# FACILITIES ASSESSMENT AND SPACE PLANNING RECOMMENDATIONS

How can Middletown get the best return on its investment in making its public library facilities future-ready for all?

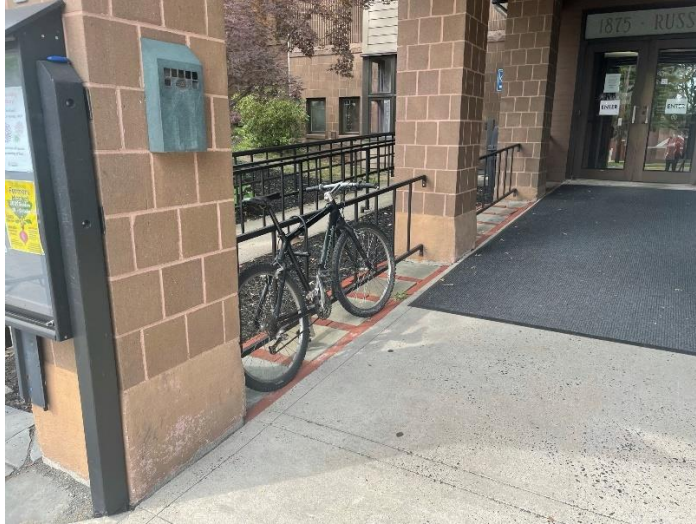
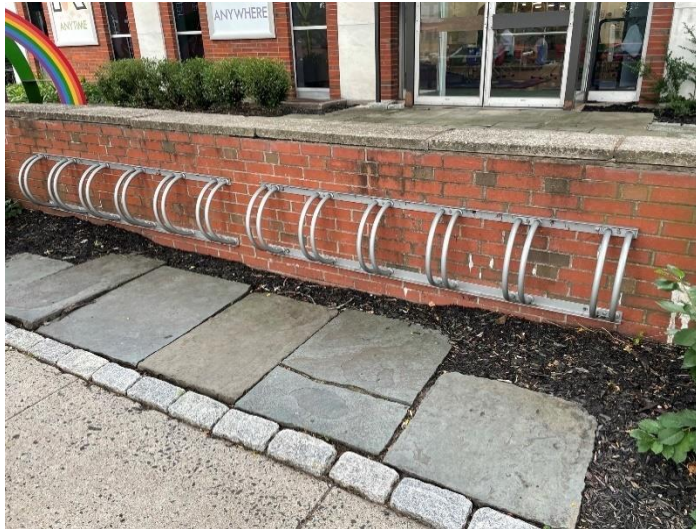
- v. Bicycle racks: During the site visits, bicycles were parked parallel to the guardrail along the covered entrance path into the library. It is not clear if this location was originally intended as a bicycle rack or has informally transformed into one.

However, if a patron were to park the bicycle perpendicular to the rail (as bike racks are typically used) then the bicycles would block the entrance and egress path. While it is a nice asset to have bicycle parking at the library as an additional mode of transportation, the bicycles should be well integrated into the architecture and landscape. Bicycle racks are also installed along the low wall in front of the Children's library patio. The pavers at this location are uneven and could be tripping hazard. No bicycles were parking at this location during our visits.

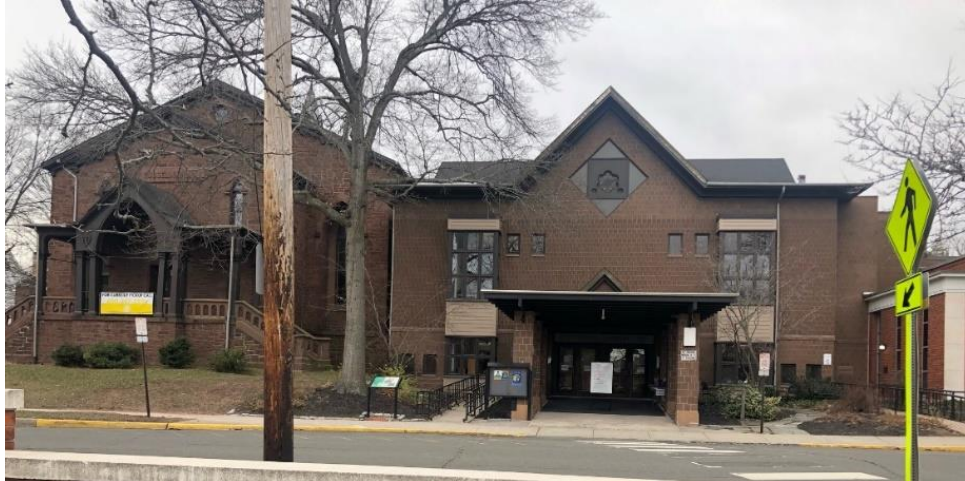
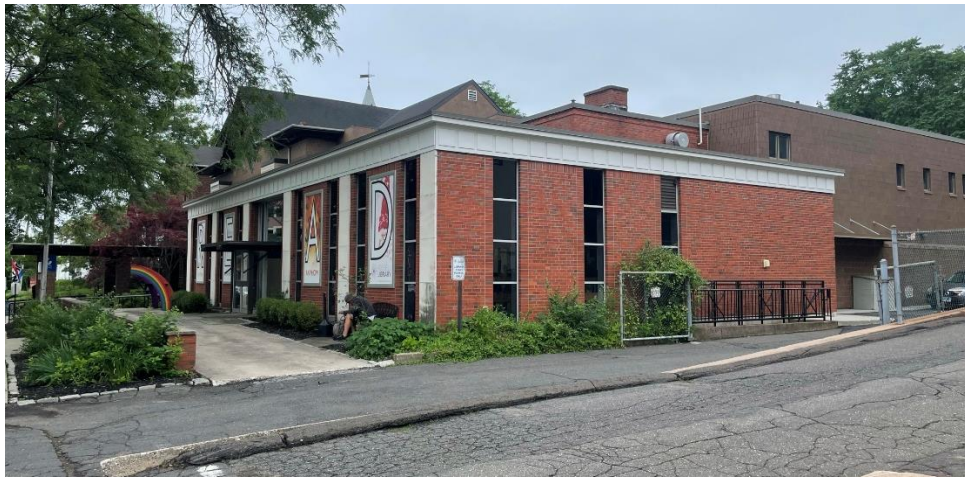
- VIII. Elevator systems- Refer to Section 2.3 Construction
- IX. Public service areas
  1. Accessibility, navigation, and wayfinding
    - i. Accessibility: While there are many ramps throughout the building, many areas of the library are still not ADA complaint including, but not limited to, the public desk (A1), courtyard (B1), main reading room bookstacks (D1), Hubbard hallway (D14), restroom, and kitchen. Ramps were added as a retrofit to bridge the different era buildings together but as a result create a lot of spatial inefficiencies and a navigational maze (D5, F2). Accessibility, however, goes beyond wheelchair access. According to the Russell Library Vision Committee Report Accessibility was defined as, “everyone can use the library, regardless of ability, language, gender expression, or any other lived experience.” A library should be intuitive and welcoming. Unfortunately, the layout of the library is not intuitive to navigate nor is the space welcoming upon arrival. Please see the section below for more information on Navigation/ Wayfinding. Another criterion for accessibility in the Vision Report was having a library that is ‘legible’ from the outside, to see what was happening inside. The monolithic front brick/ brownstone façade is a fortress with scarce openings that do not display the richness of what is happening on the inside. A library façade should spark curiosity, showcase the activities inside, be inviting, and be reflective of the character of the library and its community. The Russell library has multiple building entrances that are remnants of their previous uses prior to becoming a library. Now, these entrances are only used for emergency egress and are confusing for visitors. Due to the lack of hierarchy, the main entrance is undefined and looks like a dark exterior corridor rather than a bright gateway. Not knowing where to go and formidable entrance can intimidate people and deter them from using the library. The uses of the library should be brought out of the shadow and into the light so that it is welcoming to all.

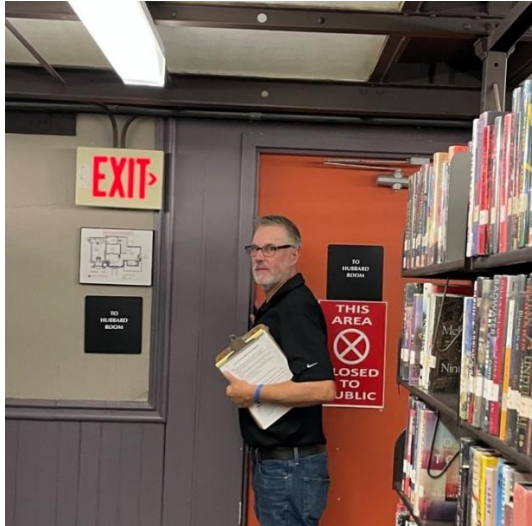
- ii. Navigation/ Wayfinding: Since the library is formed of multiple buildings, not originally designed as a library, there are a lot of spatial inefficiencies and lack of orientation/ intuition on how to navigate the building. There is also a lack visibility between and within the spaces that makes it hard for patrons to explore and for staff to monitor and interact with patrons. When there is not a connectiveness of spaces, there is not a connectiveness of people. As previously mentioned, ramps were added as a retrofit to bridge the different era building elevations together but as a result created a navigational maze that is disorienting. While the courtyard is a central anchor to the building it is not perceived as one. Small, recessed and oddly placed windows as well as level changes limit the visibility between spaces. The courtyard divides the spaces rather than connecting them. There is limited signage to guide and inform the user in the library. Some of the signage is small and illegible (F1). Other areas have conflicting signage such as the entrance door to the Hubbard room from the main Reading room (Exit, To Hubbard Room, this area is closed to the public). The signage and wayfinding should be consistent with the identity of the library and work seamlessly with the spaces. The graphics should tell the story and represent the character of Russell Library. The library has implemented a biophilia palette with inviting and comforting colors to help mitigate this issue and give identity to different spaces which is challenging given the spatial complexities.

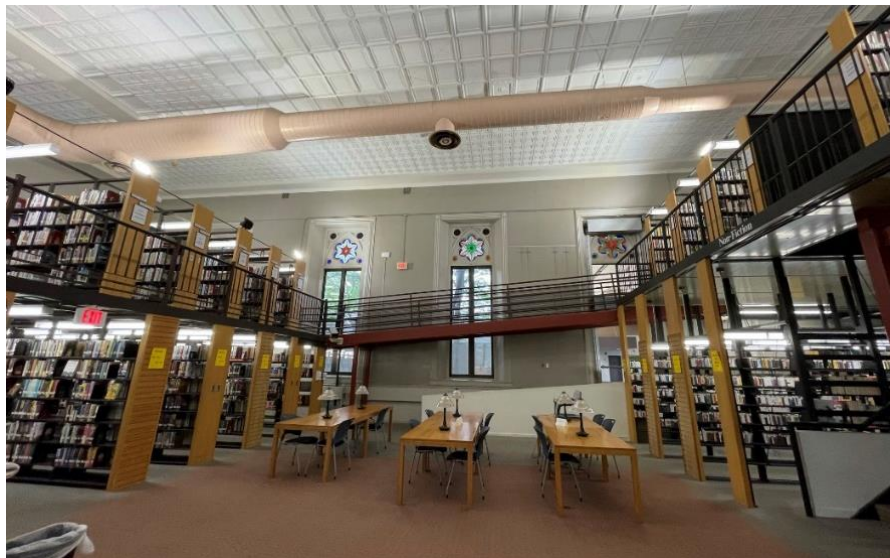
- i. Flexibility: The existing furniture/ equipment, limited mechanical capacity to accommodate changing loads, and the absence of flexible 'plug and play' power and data, and structural floor limitations contribute to the lack of flexibility at the library. The existing furniture is not easily movable, with an abundance of built-ins, heavy furniture, and furniture without wheels. The main reading room, and former church, is the most ideal gathering space to hold large scale events; however, the bookstacks block the windows and architecture, are not mobile, and are structurally integral to the floor system above. The building does not have the flexibility to relocate the books because the floors in certain areas, such as the Info Dept, are not structural adequate to accommodate the loads (E3). The library should optimize and make the most with their spaces to be versatile for everyday and event gatherings. The building spaces and furniture should be flexible to empower its users to take ownership, to accommodate various uses throughout the day, and should be adaptable to the changing needs of the future.

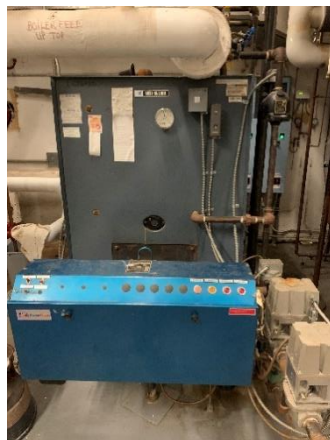
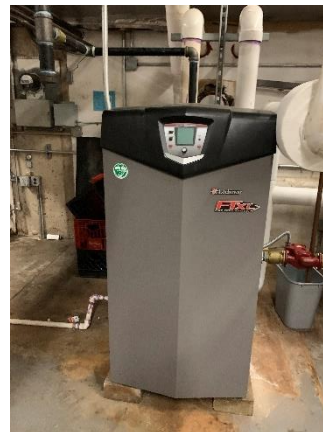
Russell Library is heated by a gas fired boiler plant located in a basement mechanical equipment room (MER). The heating plant consists of two (2) gas-fired, hot water boilers. The boilers are: a Weil McLain Model #: 588 cast iron boiler, installed in 1984; and a new Lochinvar Model FTX600N high efficiency, condensing boiler, installed in 2016. Two (2) base-mounted circulating pumps distribute hot water to heating coils in the building's air handling units, cabinet unit heaters and finned tube radiation located around the facility.

The older (1984) boiler appears in satisfactory operating condition, however, it has exceeded its useful life expectancy of 35-40 years and is of a lower operating efficiency of modern boilers and should be replaced. The newer boiler is a high-efficiency condensing boiler consistent with modern boiler standards and with useful life expectancy to serve the facility for decades to come. However, both boilers are fossil-fuel burning and the library's climate action goals consistent with their Strategic Plan to be "future ready ... and plan for change" will require their phase out in favor of electrification and renewable energy systems.

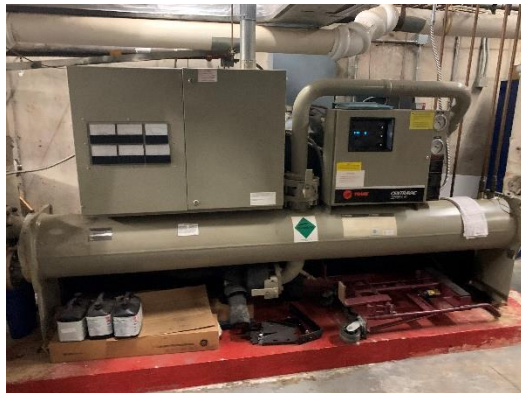
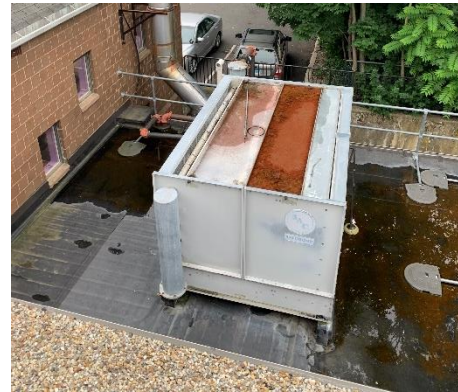
The chiller is a Trane Model #: RTHA130A, rotary screw chiller and the cooling tower is a Baltimore Aircoil forced draft model, both were installed in 1981. The chiller plant serves cooling coils in the building's air handling units that serve all spaces in the facility.

The chiller appears in satisfactory operating condition. Its rotary screw compressor technology is still manufactured in modern chillers and capable of achieving high operational efficiencies, however, it has the downside of high-pitched noise levels and is not suitable to be located adjacent to occupied spaces because of unhealthy indoor environmental conditions. The chiller has also reached the end of its useful life expectancy and it utilizes R-22 refrigerant that has since been phased out because of its detriment to the environment.

The cooling tower shows visible signs of corrosion in its top water basin and has also exceeded its useful life expectancy. Also cooling towers can

The chiller plant should be replaced with new environmentally friendly systems as part of any building upgrade program.

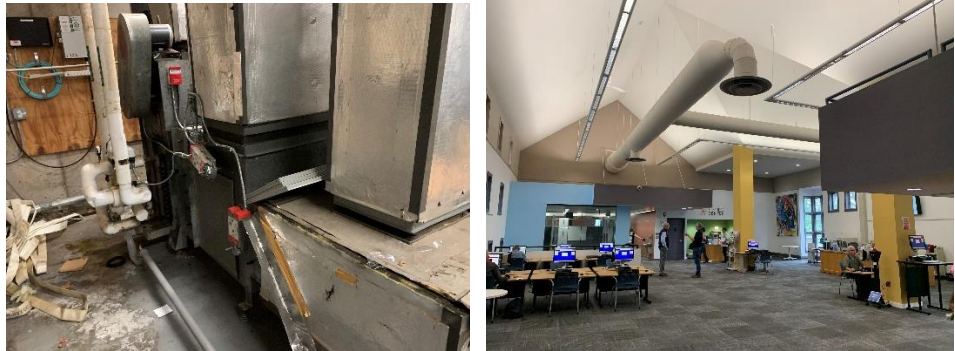
A series of eleven (11) chilled water/hot water air handling units, located in five (5) MER's throughout the facility, provide heating, cooling and ventilation to all areas of the library. The air handling units contain a hot water preheat coil, chilled water coil, and supply air fan. The air handling units serve ductwork distribution systems serving each space in the facility, many of the spaces contain exposed round ductwork where it is a visible part of the interior design.

The building's piping distribution system serving the air handling units is a 2-pipe system, meaning the same pipes that distribute hot water to the units in heating mode, distribute chilled water to them in cooling mode. These 2-pipe distribution systems are not suitable for facilities like Russell Library where heat and cooling may be required simultaneously in different spaces in the building. We understand this has resulted in major temperature control problems and operational inefficiencies of having to drain all of the water out of the system for changeovers from heating to cooling.

The air handling units were mostly installed in 1981, making them 40-years old, obsolete and beyond their useful life expectancy. The following

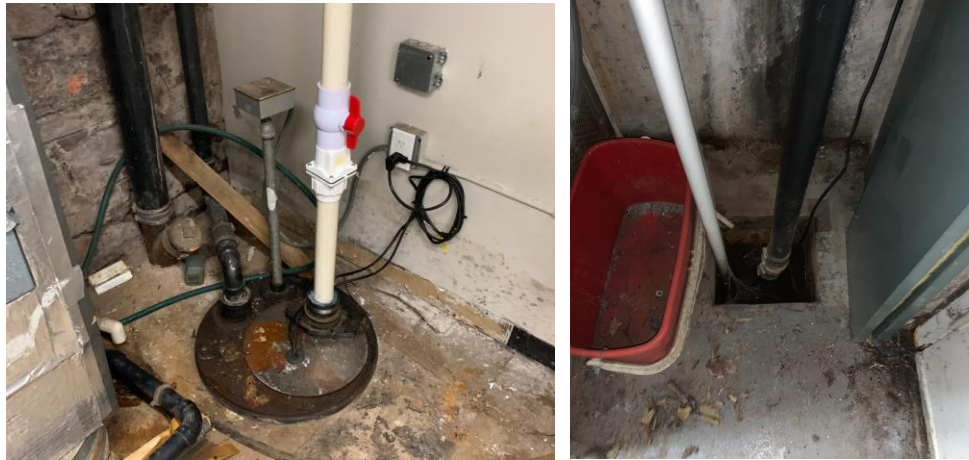
the gravity system. The larger simplex sewage ejector, manufactured by Liberty Pumps, model PRG101A (1HP, 115V, single phase) is located on the first floor Mechanical room, adjacent to the AV / Teen Services Office room.

Despite the routine maintenance, the existing unit exceeds 15 years in age and appears to require replacement.

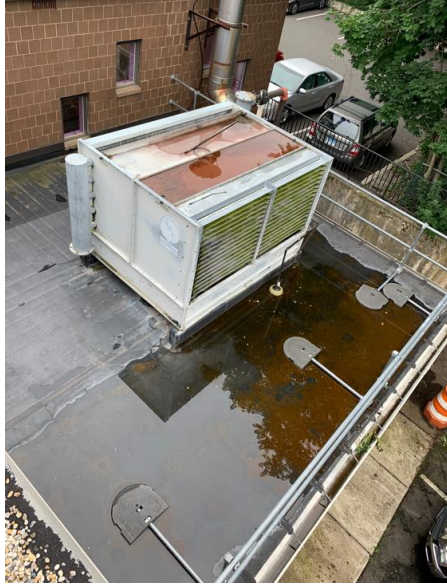
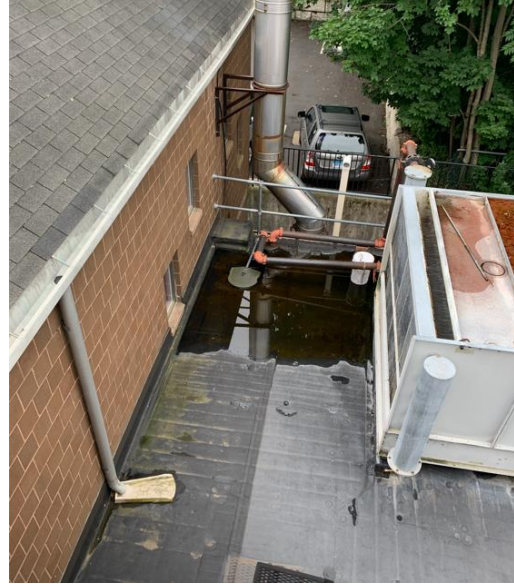
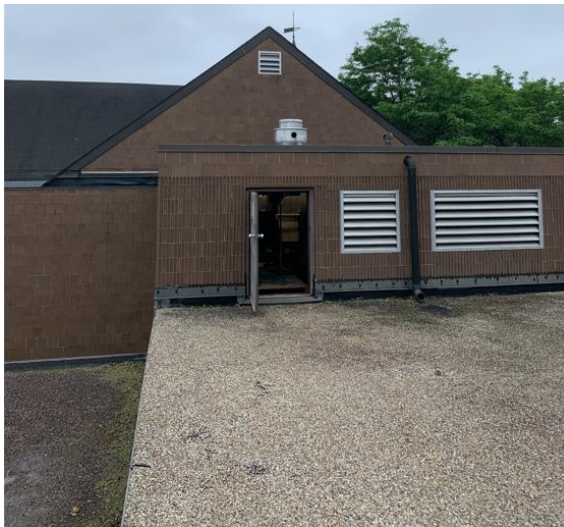
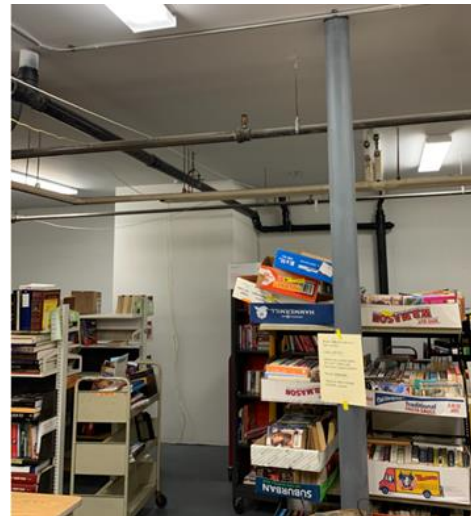
pipng distribution has taken place. Much of the existing drainage system is dated, with signs of heavy corrosion.

Portions of the horizontal stormwater piping were observed without insulation, which protects against condensation in ambient temperatures.

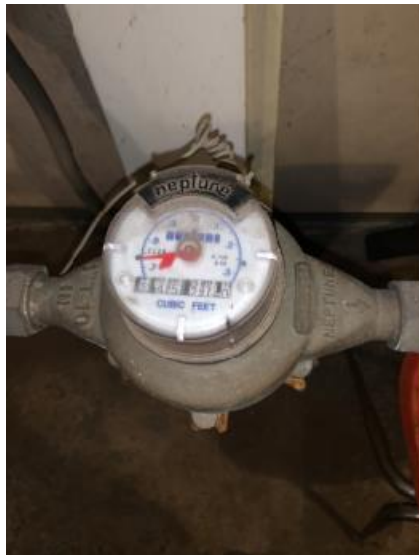
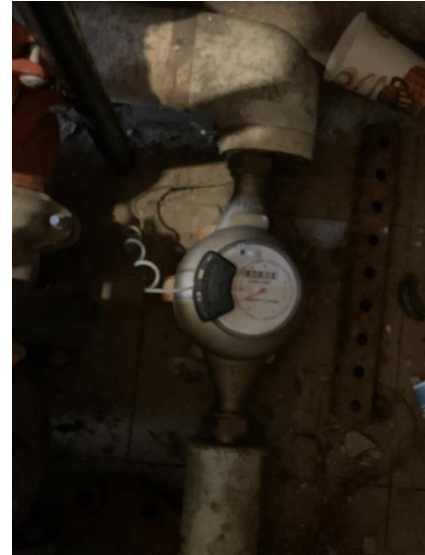
The building is served by (2) 1-inch domestic cold water services from the municipal water system. The cold service enters the building from the southeast mechanical room from Broad Street and northwestern mechanical room from Broad Street. Both services are metered by Neptune Meters, however, are not equipped with a backflow device that protects the municipal system from potential cross-contamination.

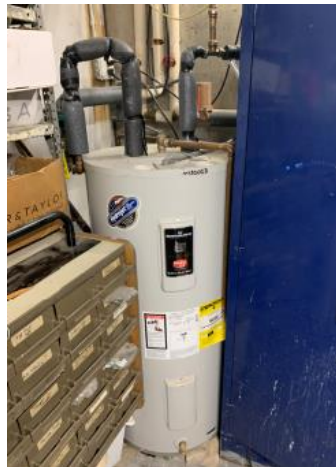
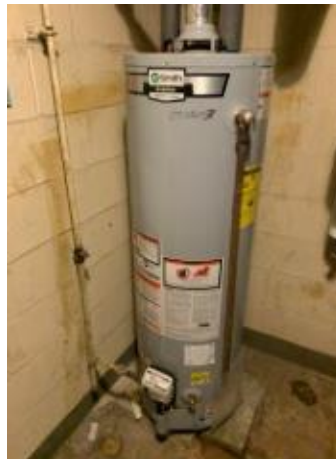
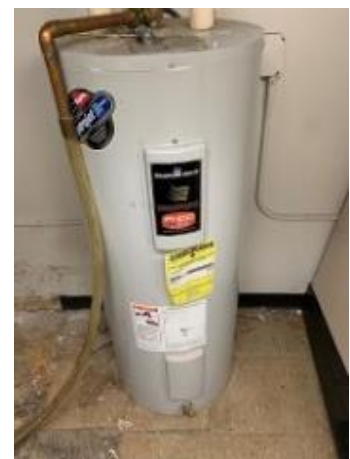
Each water heater delivers hot water to zoned portion of the building. All units appear to be uninsulated in some areas. The units should also be mounted on a housekeeping pad to minimize corrosion.

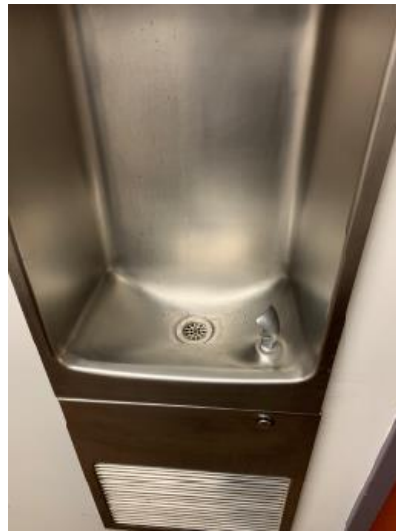
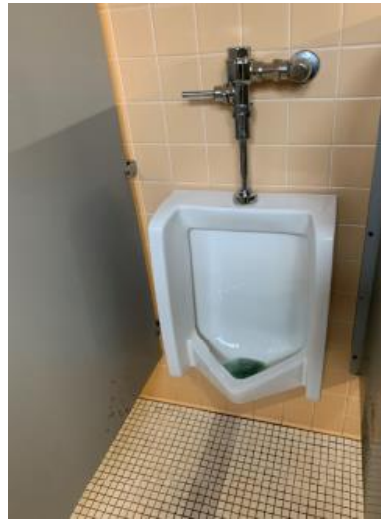
Several existing bathroom fixtures observed are not in compliance with ADA requirements. Toilets/urinals are not mounted at heights in accordance with ADA standards. Several lavatories were not equipped with pipe coverings adhering to standards for ADA protection.

Fixtures are not equipped to meet current water conservation devices in compliance with U.S. Environmental Protection Agency (EPA) Water Sense program.

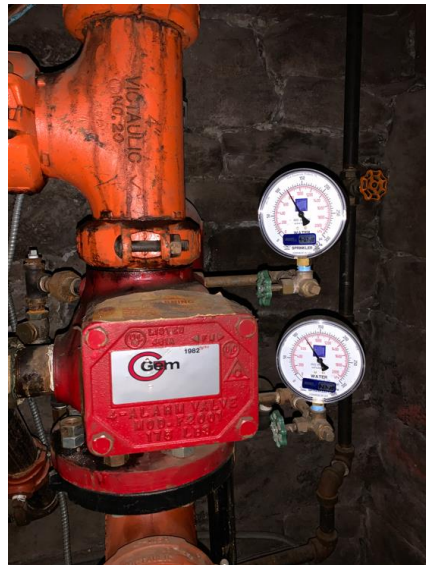
There is an incoming combined 4-inch fire sprinkler and standpipe service, entering the building from Court Street, off the municipal water main @ 115 psi static pressure. The existing service is not equipped with a backflow prevention device to protect the municipal water system from contamination.

Upon entering the building, the fire service connects to a 4-inch alarm check valve assembly, providing notification of fire activity.

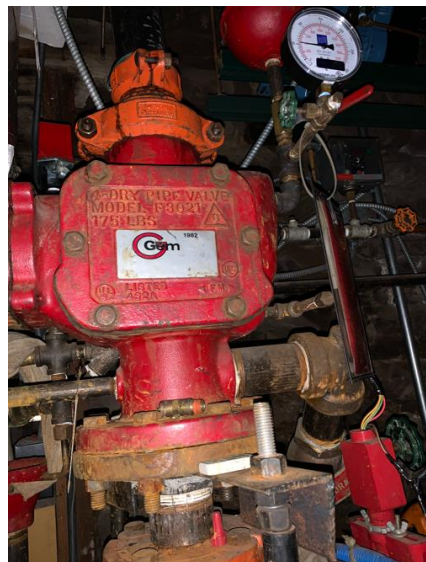
Downstream of the alarm check valve, the 4-inch fire protection system splits to supply the automatic wet sprinkler / standpipe distribution for each floor, in addition to a feed for a dedicated 4-inch dry sprinkler valve assembly.

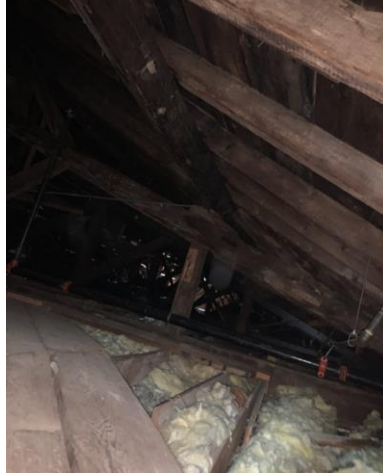
The 2-1/2-inch dry main serves the sprinkler distribution in the attic above the main circulation library on the Mezzanine level. This area is subject to freezing and constructed of combustible materials, therefore

dry sprinklers were required to ensure proper protection without the heads rupturing when subject to ambient temperatures in the winter.

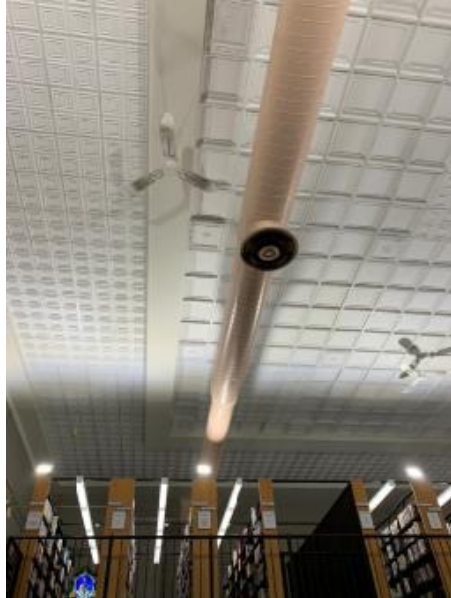
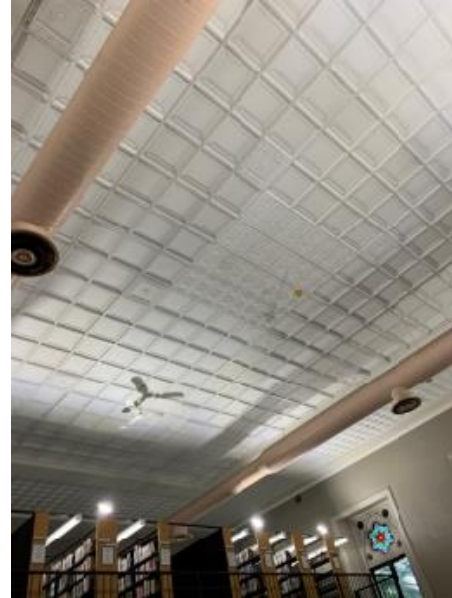
The circulation area of the library in the old church, with the dry sprinkler distribution within the attic area is not equipped with sprinkler protection, despite the tiers of books stored in the facility.

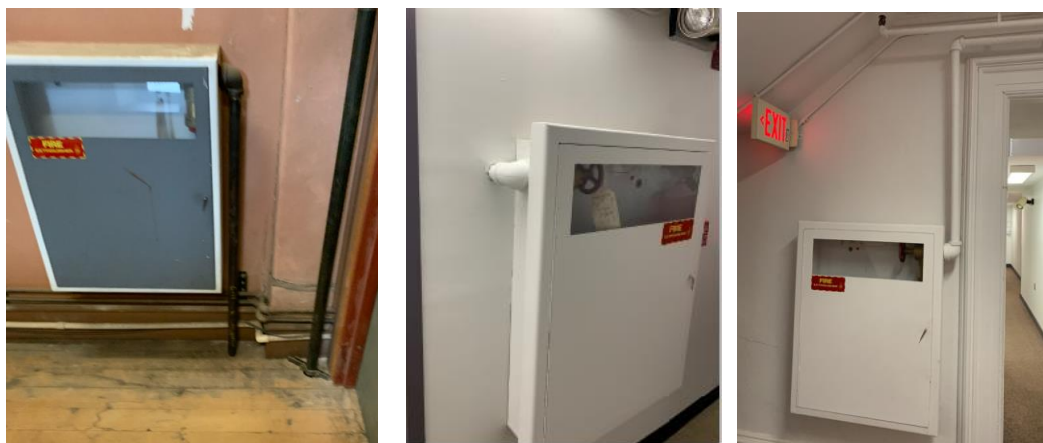
Hose stations are based on Class III standpipe systems, based on NFPA 14. The fire hose stations, supplied from 1-1/2-inch feeds are located in egress stairs of each building level and auxiliary locations where travel distance from the stairways exceeds code standard. The supply main serving these hose stations were not sized at 4-inches in accordance with code.

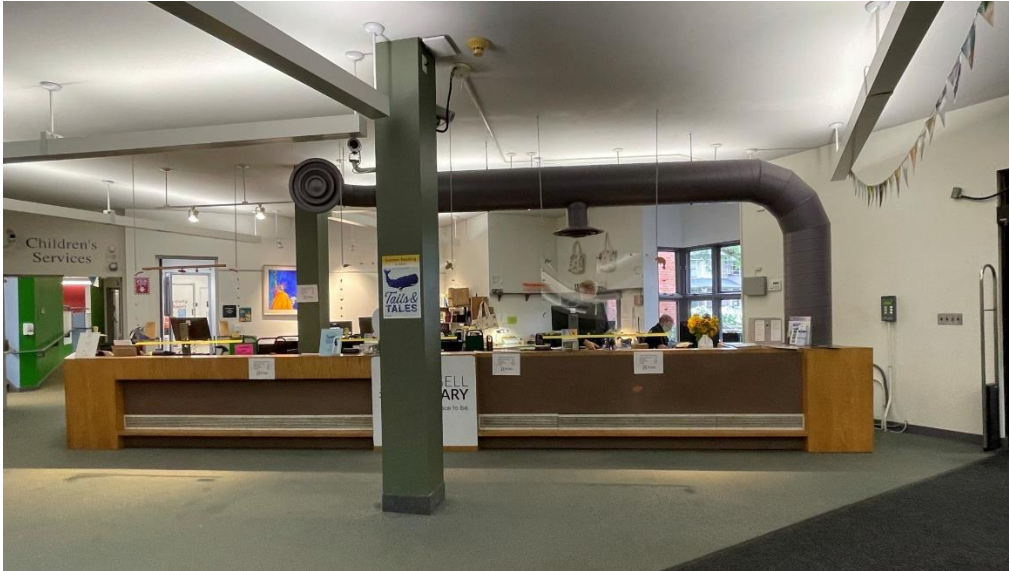
1. Public Desk is not ADA compliant.

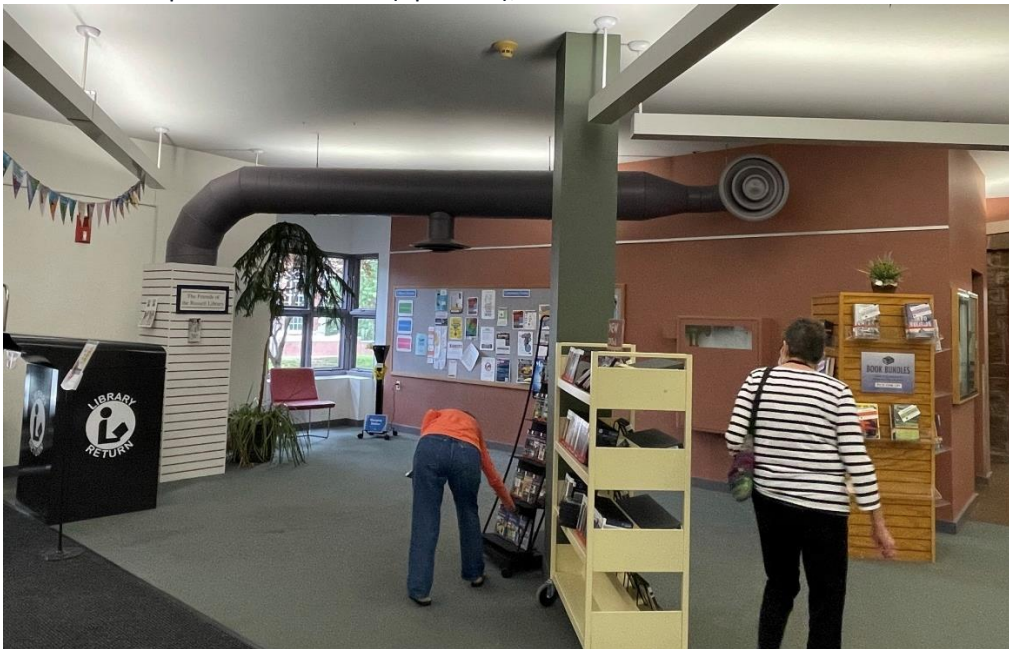
2. No self-checkout; heavily reliant on staff intervention.
3. Air flow: Best practice is vertical (upwards), not horizontal

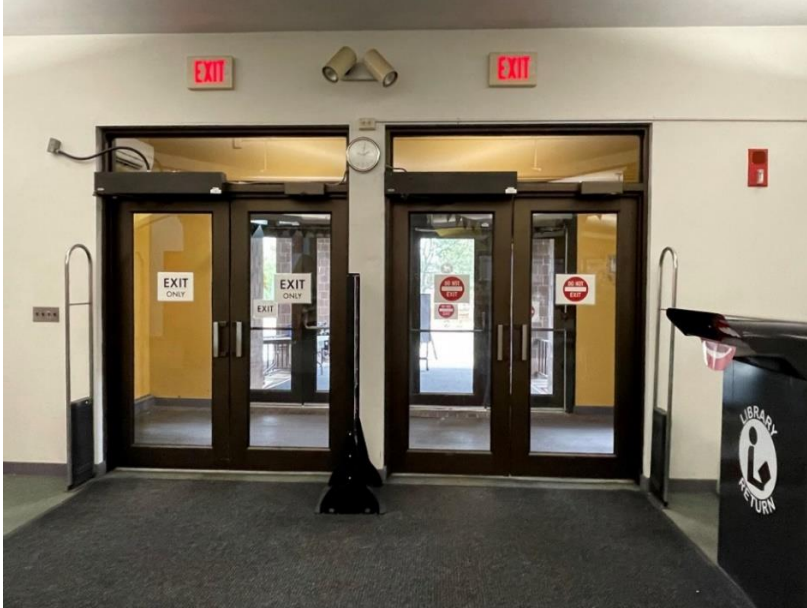
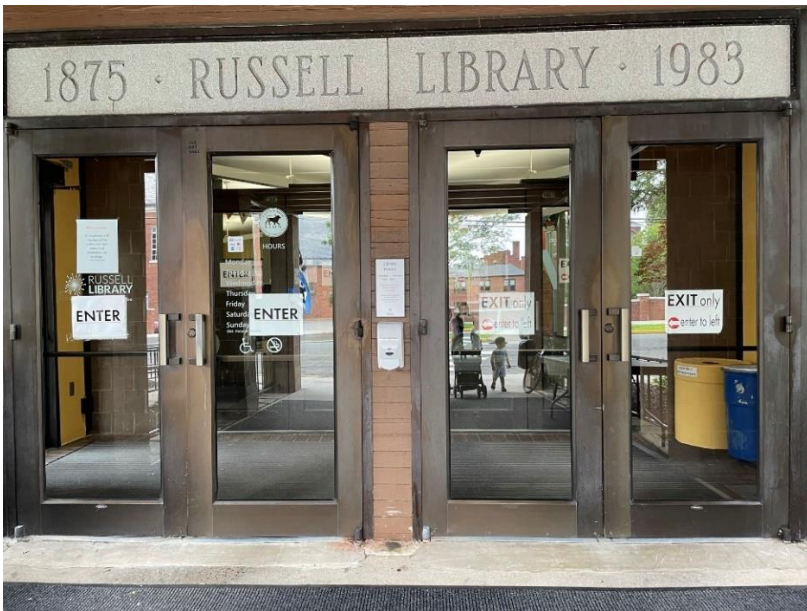
4. Doors: Not energy efficient (should be automatic/ sliding with vestibule). Signage on entry doors is cluttered and unwelcoming. The entryway is your first impression of the building. To quote the architect Juhani Pallasmaa, “The door handle is the handshake of the building.”

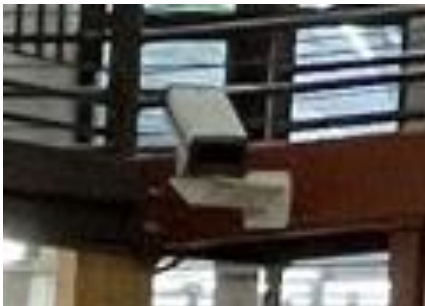
5. Security system is outdated; not viewable online (local server)

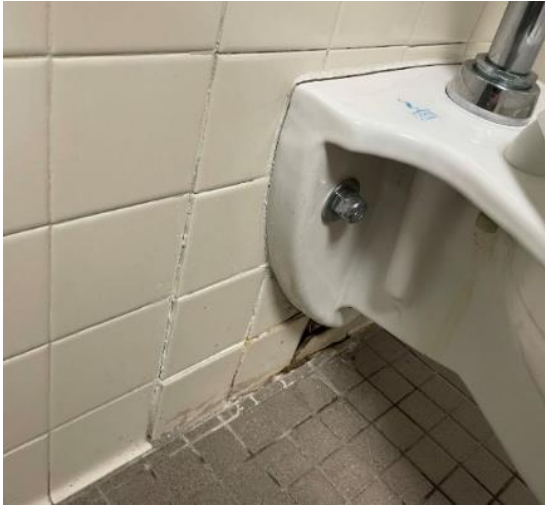
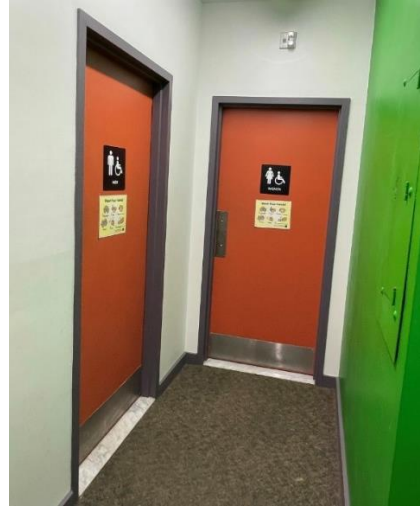
6. Public Toilets falling off walls; recurring sewage smells; no diaper changing stations are available except for one in the Family Restroom.

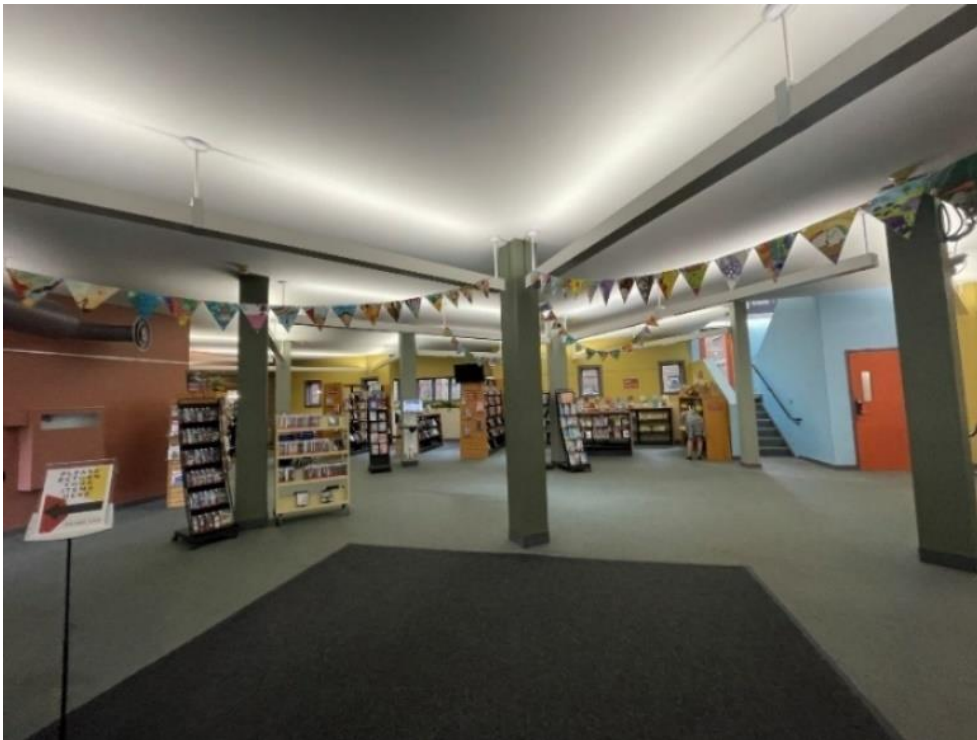
7. Only one all-gender restroom in building.
8. Worn carpet = safety/ tripping hazard.
9. The Lobby has little visibility into other areas. There are an abundance of columns and small openings to connected areas on the far ends of the lobby, so it is difficult to navigate and is unwelcoming. This includes the entrances to the Children's area, Young adult, Adult Main reading room and Info Dept.

*Lobby from the entrance looking towards the Young adult and Main Reading*

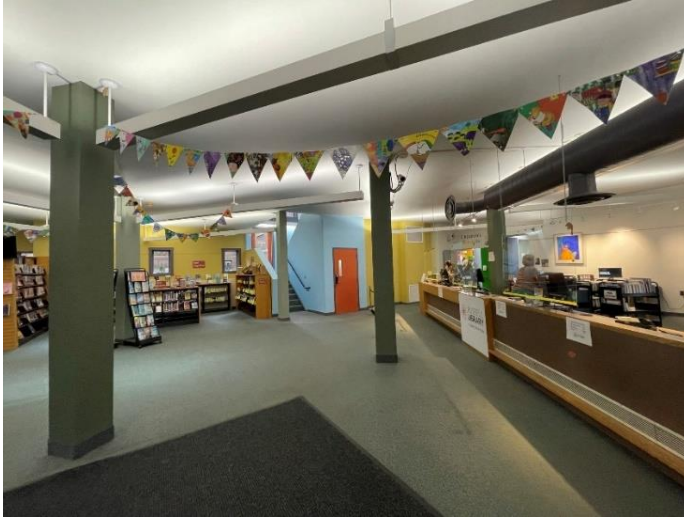
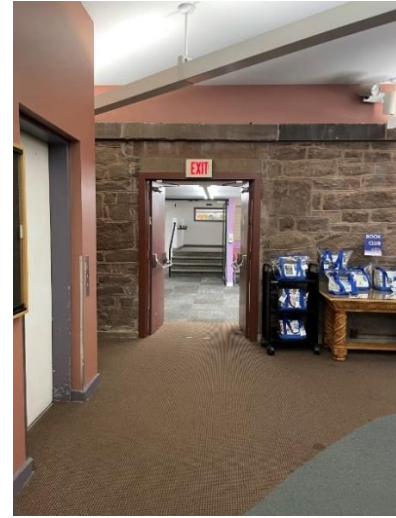
*Left: Lobby from the entrance looking towards the Info Dept and Children's area.  
Right: Entrance from Lobby to the Young Adult and Main Reading room. Small opening, little visibility, no wayfinding signage.*

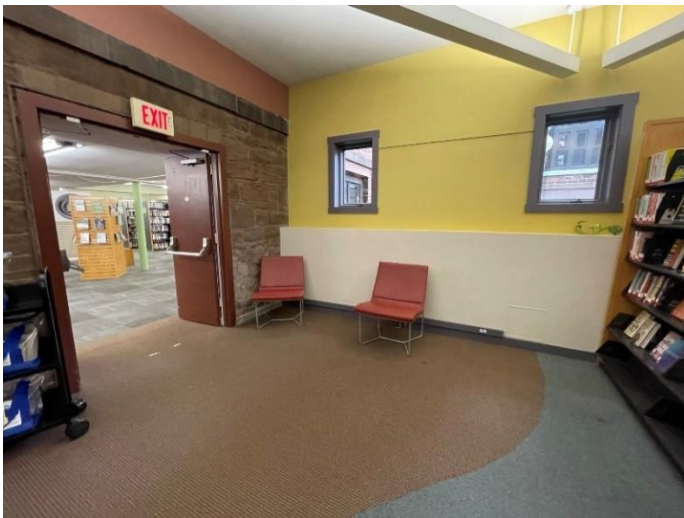
10. Scarce uninviting lounge furniture

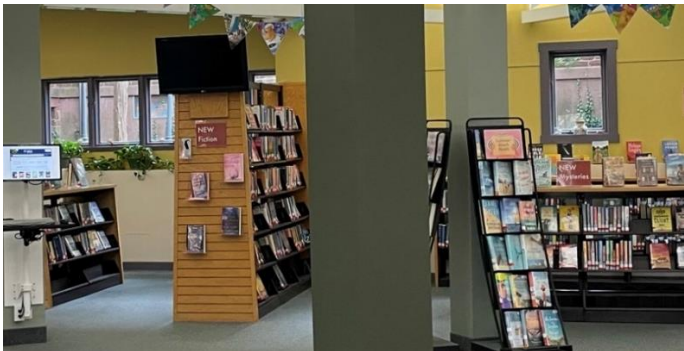
11. Windows to the courtyard are high up and dark. There is an elevational change between the lobby and the higher courtyard that is awkward and disconnected. The little windows do not highlight the qualities of the courtyard nor bring in natural light.

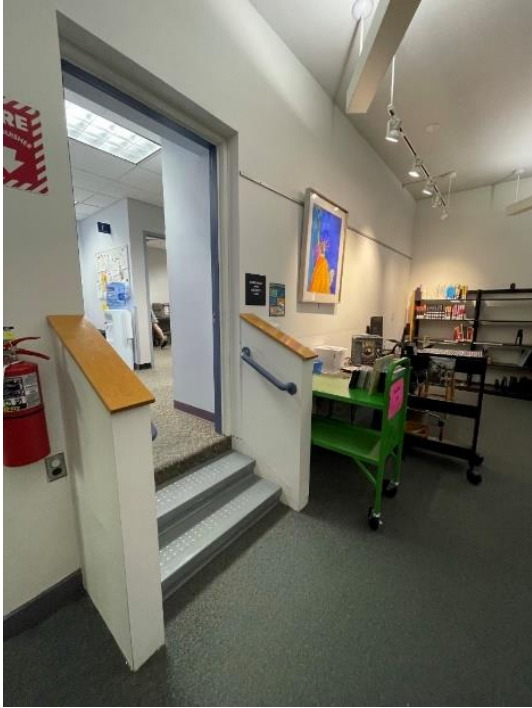
12. Indirect lighting creates hot spots on the ceiling. Space is too dark (See Image A9).
13. Elevation change between back of house staff areas behind circulation desk.

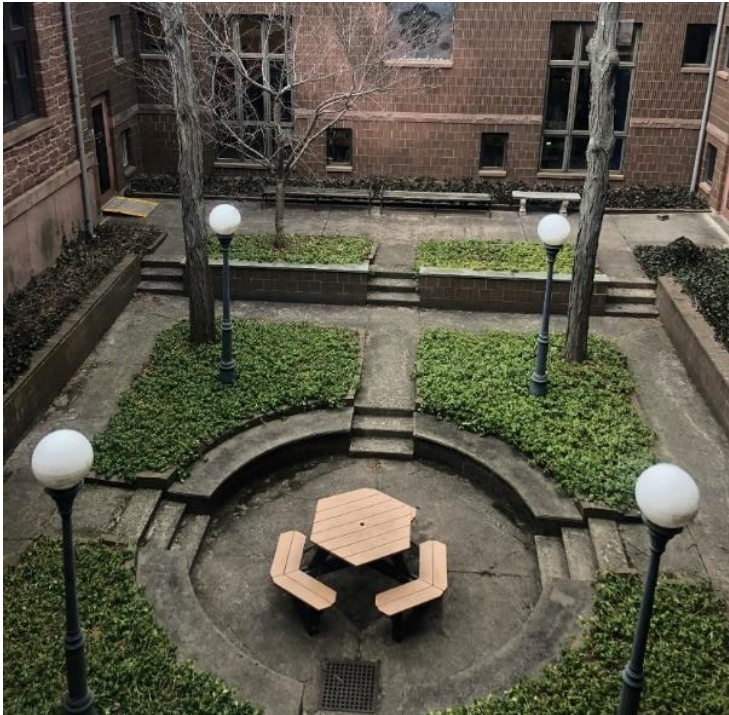
1. The courtyard is not ADA compliant. It has many level changes within it and steps throughout. Only a small area is wheelchair accessible.

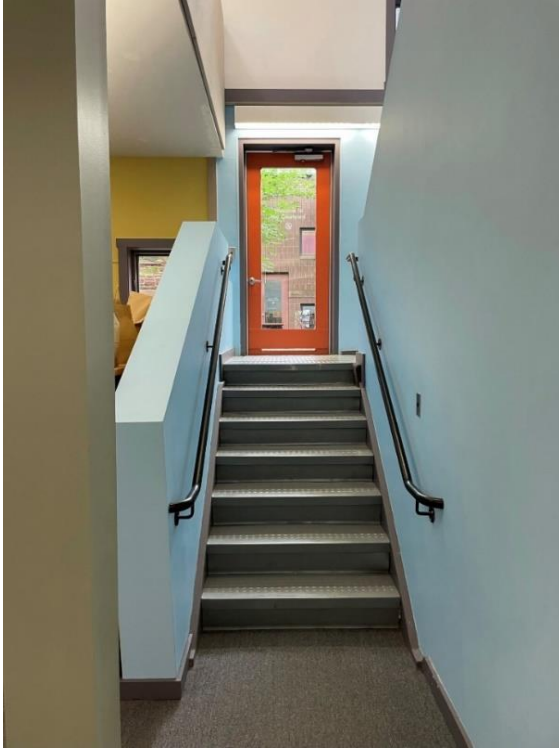
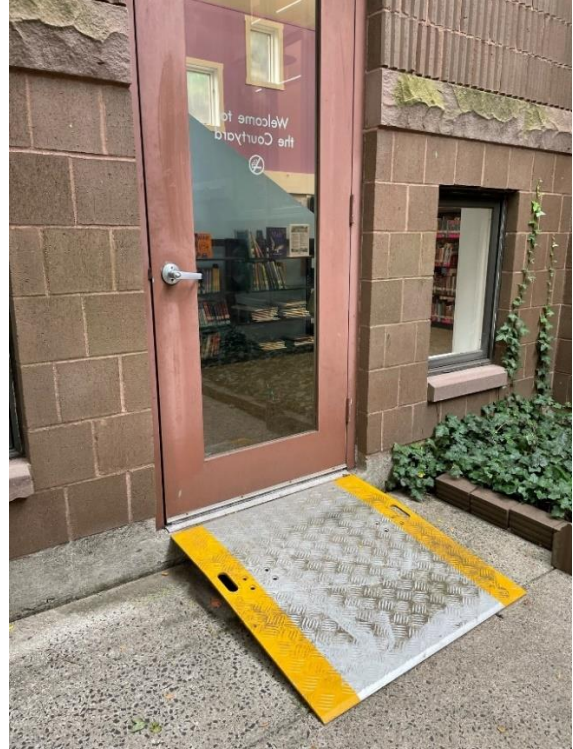
*Right: Ramp entrance from Children's area to the courtyard. Not fully ADA compliant.*

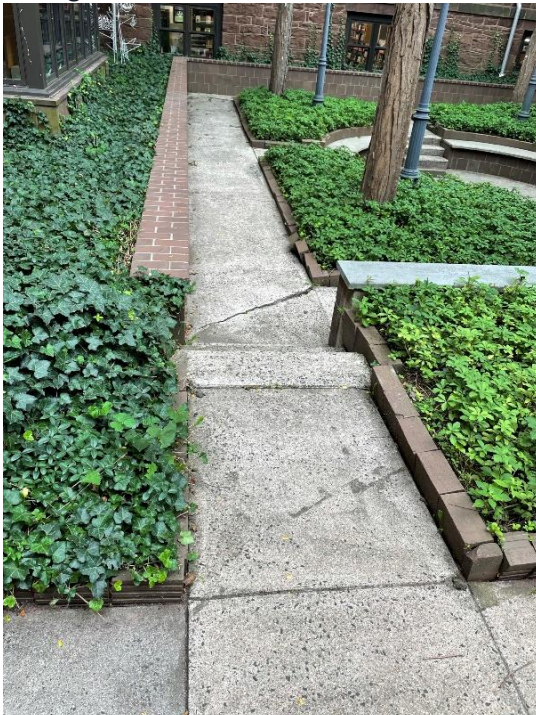
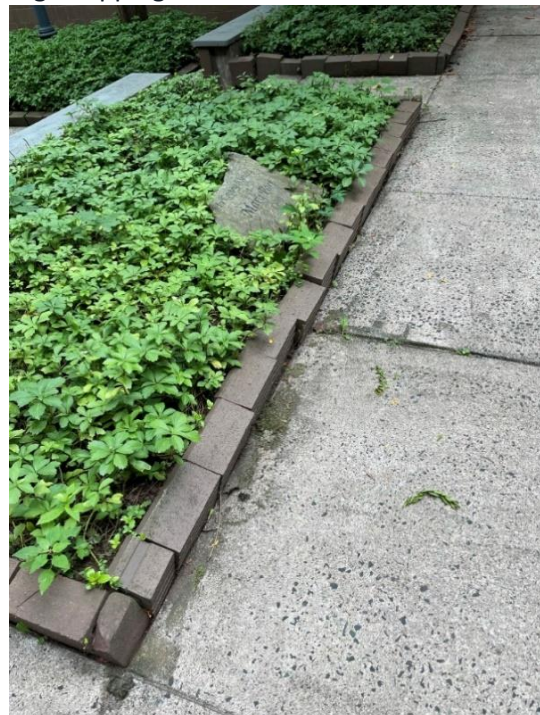
3. Paving cracked and uneven. Flower bed curbs falling. Tripping Hazard.

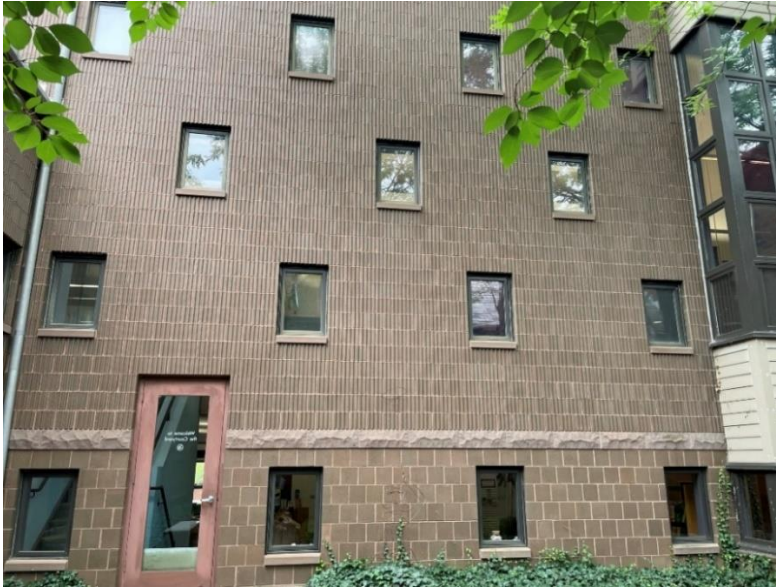
4. Window openings between the library and the courtyard are small. Lack of visibility between the library and the courtyard for views, daylight and a sense of connection.

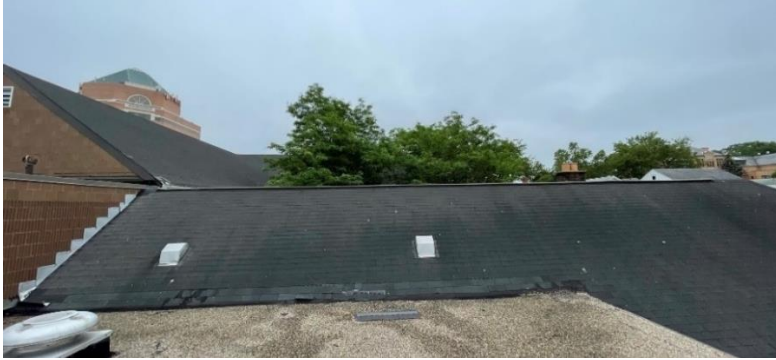
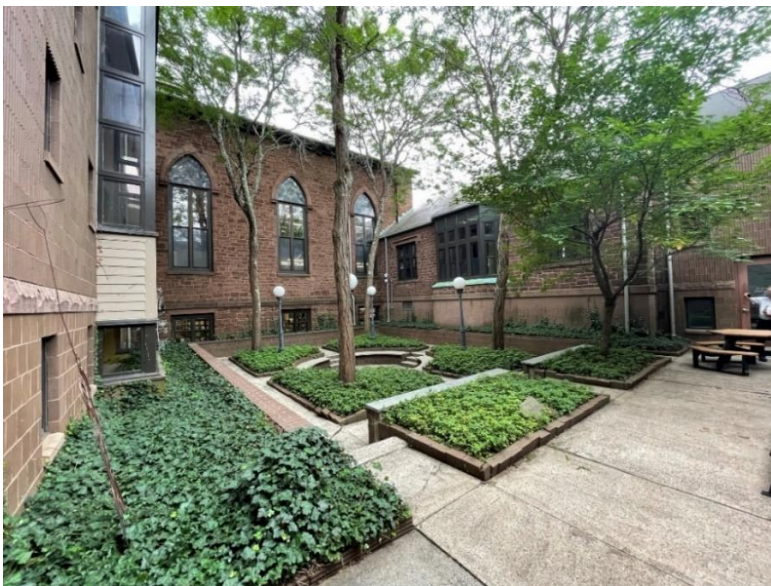
5. Poison ivy; Dead/ dying trees are health hazard and are damaging the roof

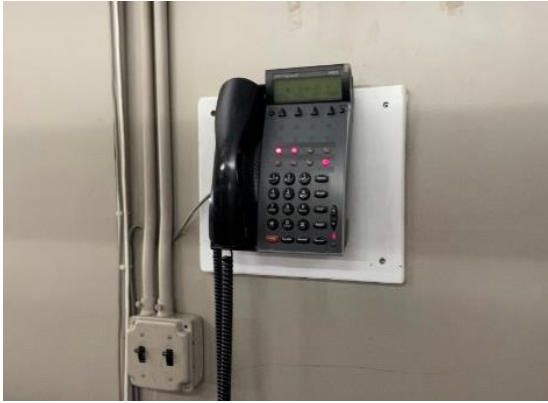
1. Security: Light switches outside offices; PA system is based on phones (not wall/ ceiling speakers)

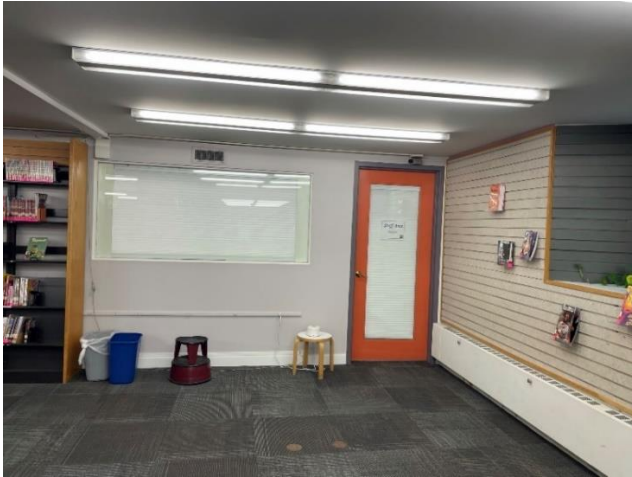
2. Staff offices scattered throughout 45,000 sf facility

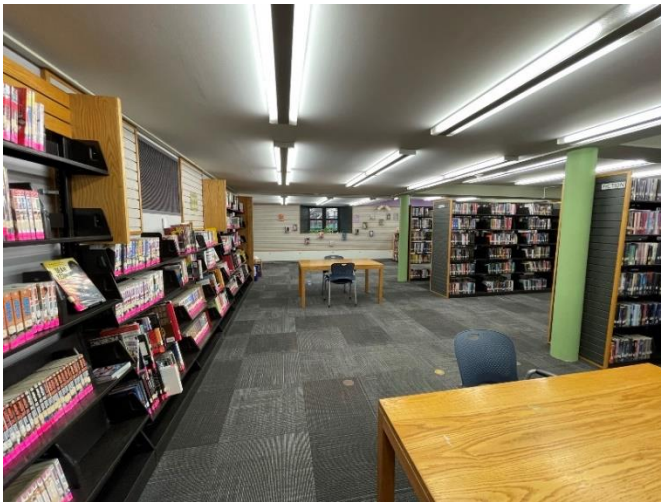
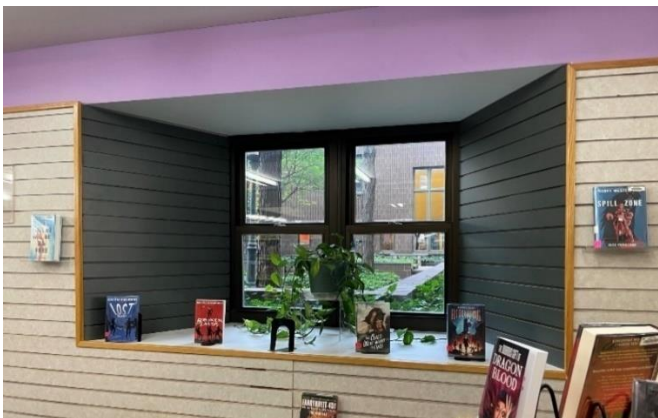
5. Teens are relegated to the basement. Windows are small and are deeply recessed. Little daylight or connection to the exterior and courtyard.

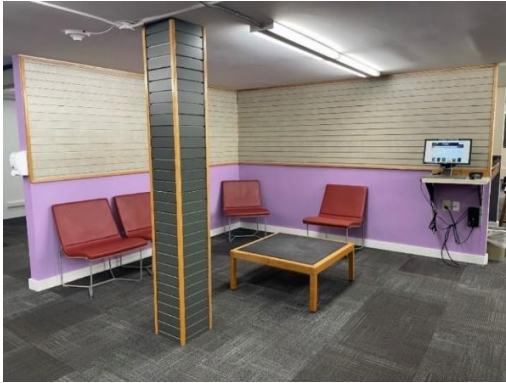
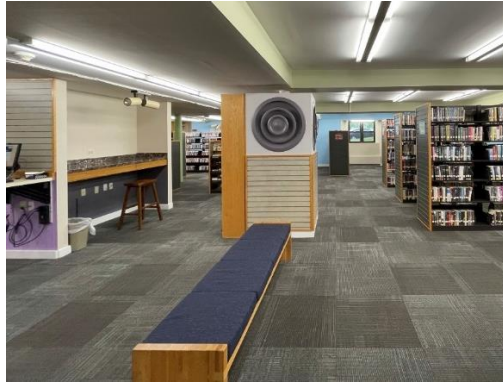
6. Furniture is scarce and uninviting. No areas for collaboration or shared participation.

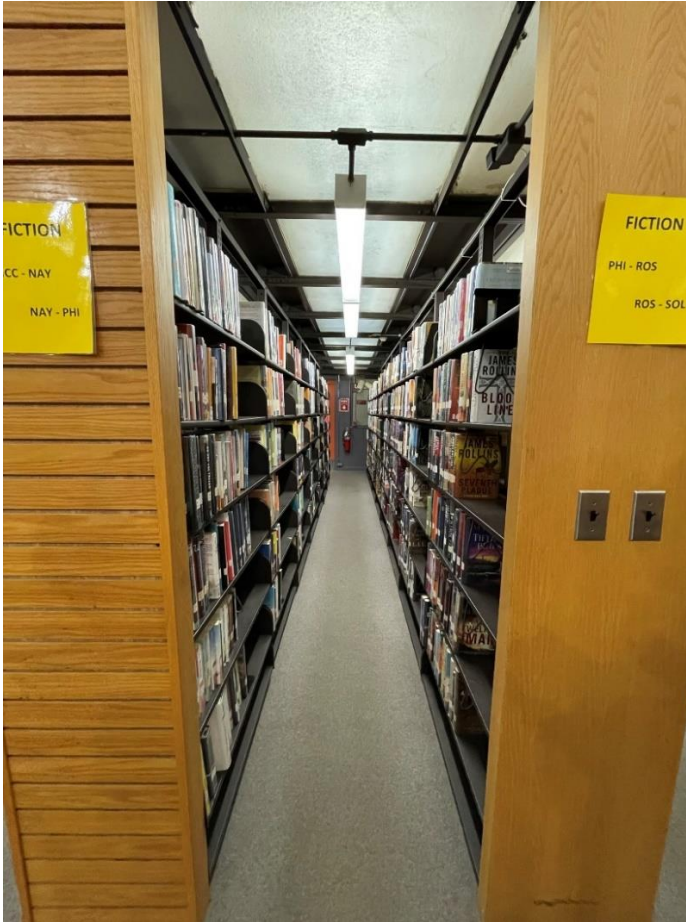
1. Stacks are nowhere near ADA-compliant. Would need to completely rebuild because they are structural and integral to the floor system and egress.
