# FACILITIES ASSESSMENT AND SPACE PLANNING RECOMMENDATIONS

How can Middletown get the best return on its investment in making its public library facilities future-ready for all?

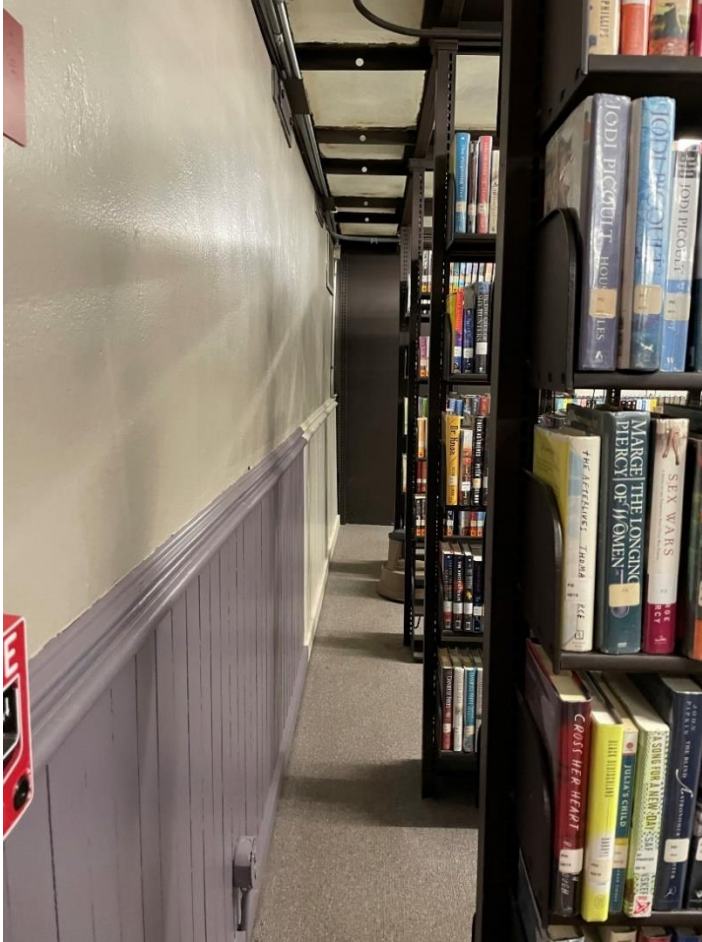
3. Nearly impossible to monitor (nooks and crannies). Dead ends for egress. The library would lose a lot of bookstacks to make this area compliant and accessible.

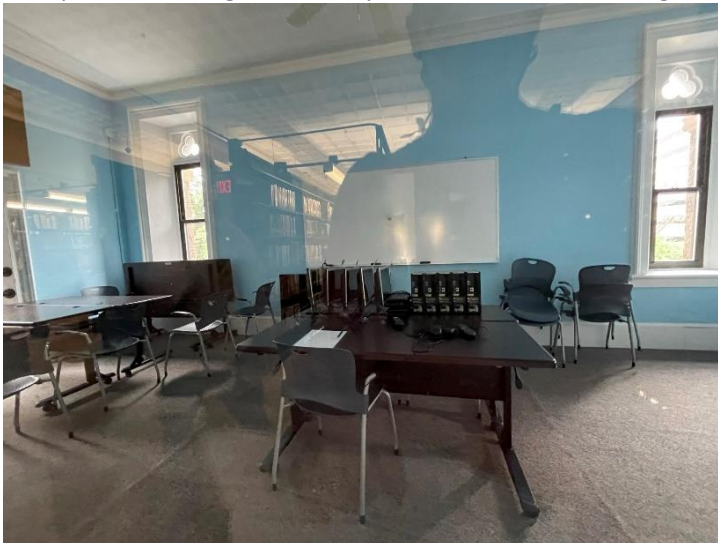
4. Two public meeting rooms only; no intercom in meeting rooms

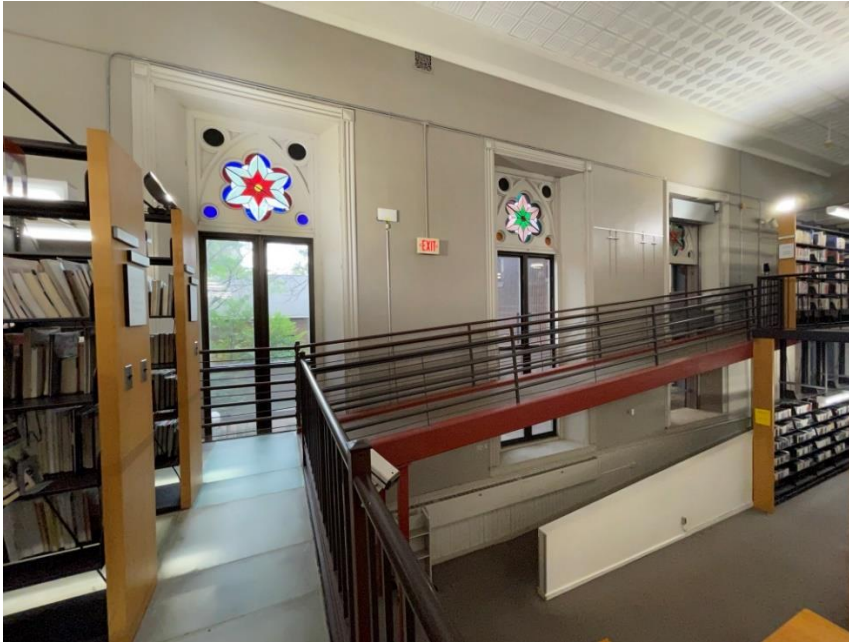
5. Exit signs are not visible and are confusing. There is not enough visibility of the exit signs which is a life safety hazard. On the mezzanine level in the old church building there is an exit sign above the ramp that has arrows in both directions. One direction leads you to an exit sign above the open communicating stairs on the east side and the other arrow leads to an exit sign with no exit. There is no exit sign above the open communicating stair on the mezzanine level on west side. If the open stair on the west side is not an egress stair, then the west side of the mezzanine is a large dead end, and the travel distance is too long which is a life safety hazard. See codes notes for additional information.

*Two directional exit sign only leading to one exit stair.*

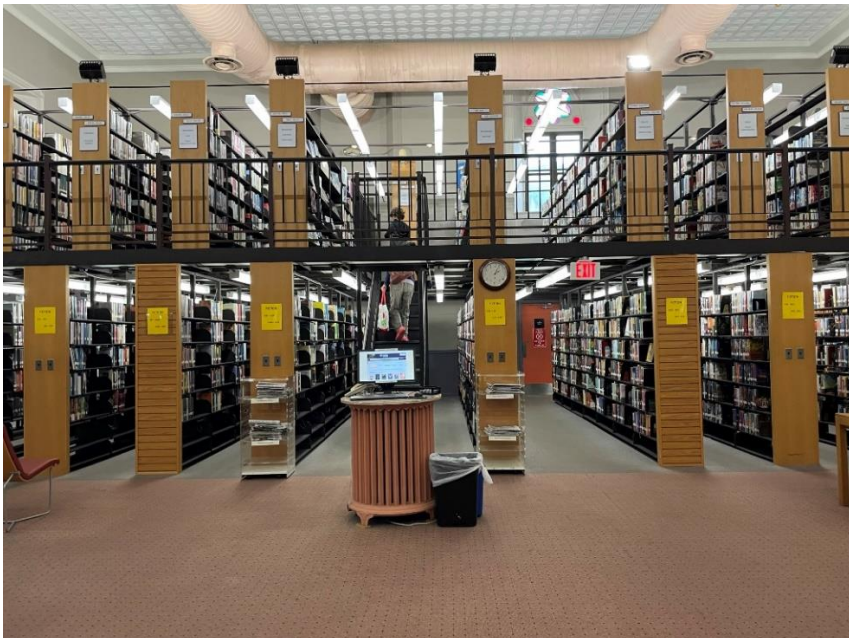
*No Exit sign above open communicating stair on the West side*

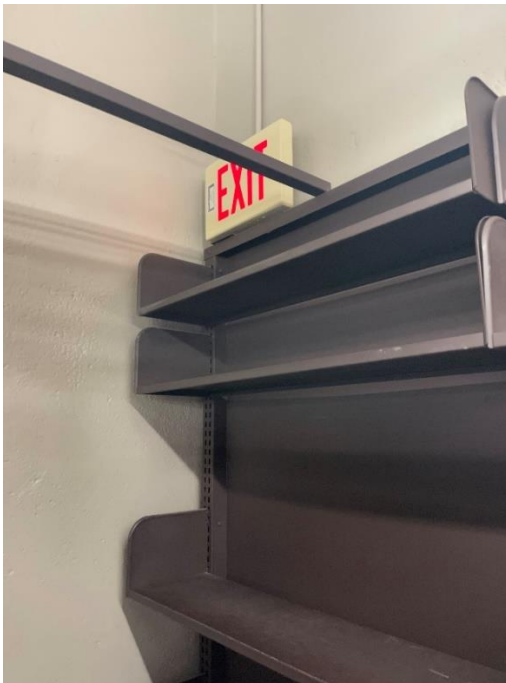
*Exit signs that does not lead anywhere. The path width is too narrow for egress between the book stacks and the wall.*

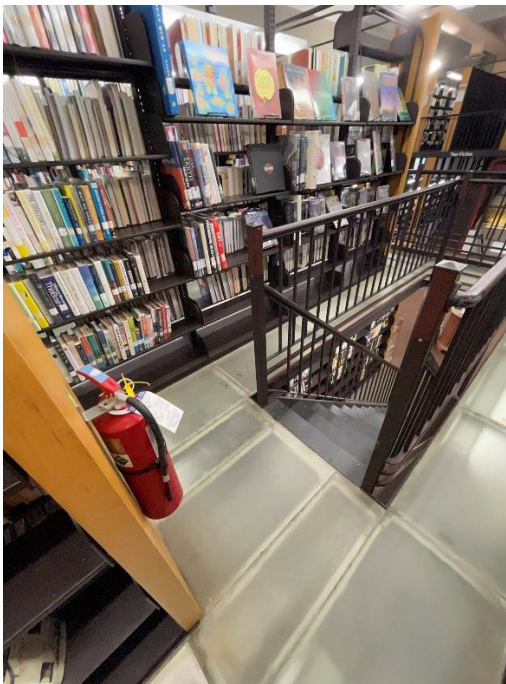
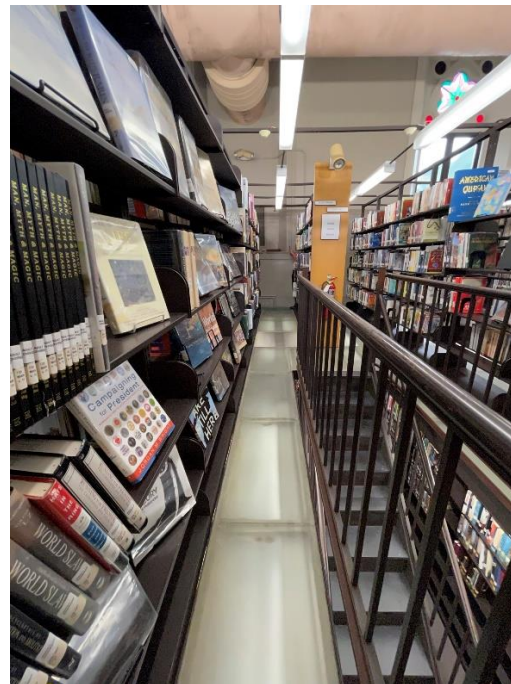
6. Egress widths too narrow. Not enough egress width around the stair.

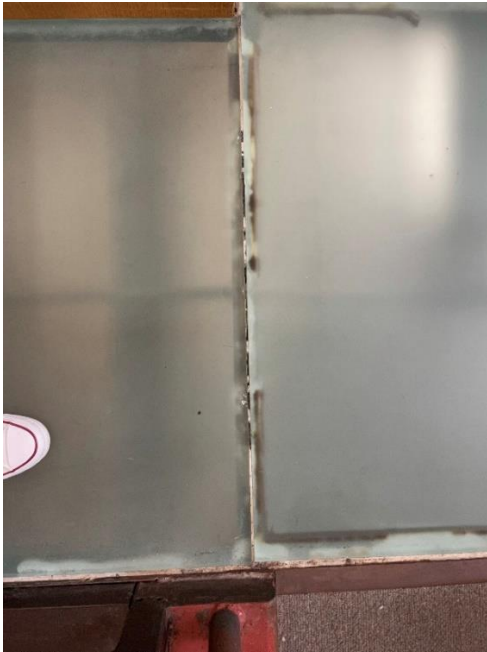
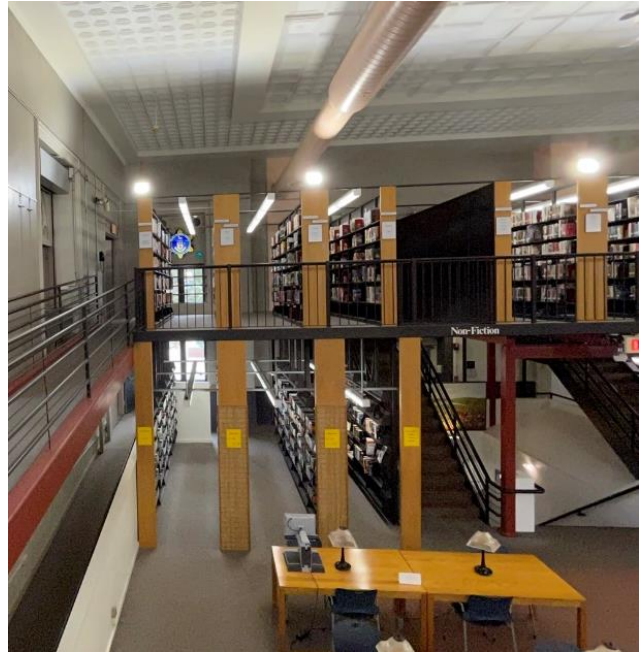
7. Floor finishes are worn, including the carpet and the glass floor is damaged.

8. Lights above the mezzanine level bookstacks have a lot of glare and is hard on the eye. (see right image above)
9. Clear width between the bookstacks is too small (ADA)
10. There are 1 ½ hour fire rated doors between the old church/ main reading room and the info department on the mezzanine level. The doors are on a hold open tied to the electrical system. This would potentially indicate the old church buildings and the info department building may have needed to be fire separated. However, there are openings between the two buildings without any fire separation at the old church window openings.

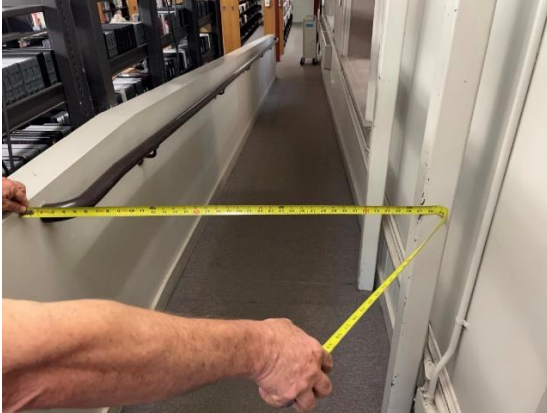
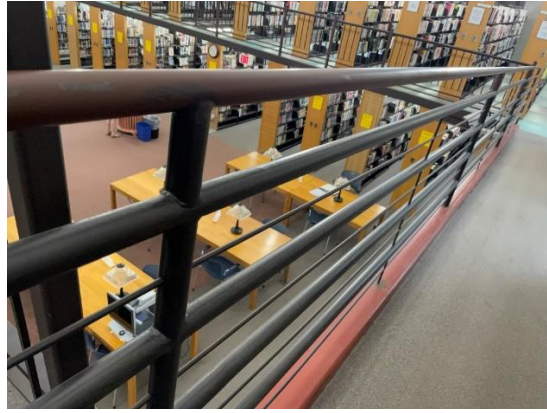
11. The ramps only have handrails on one side in certain locations and are not continuous. The ramps do not appear to have the proper clearance width in certain locations.

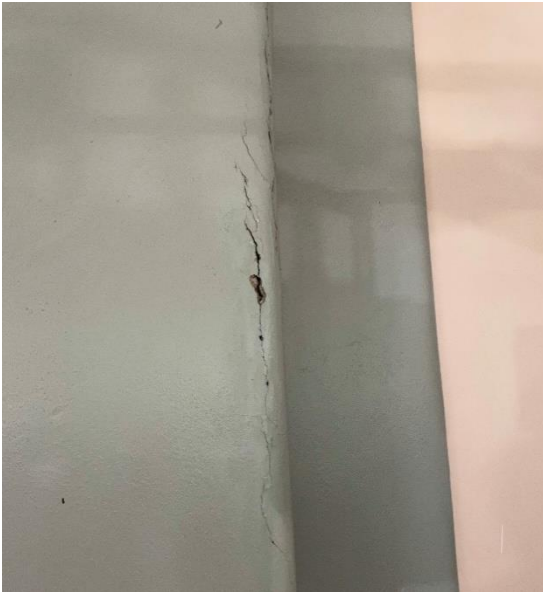
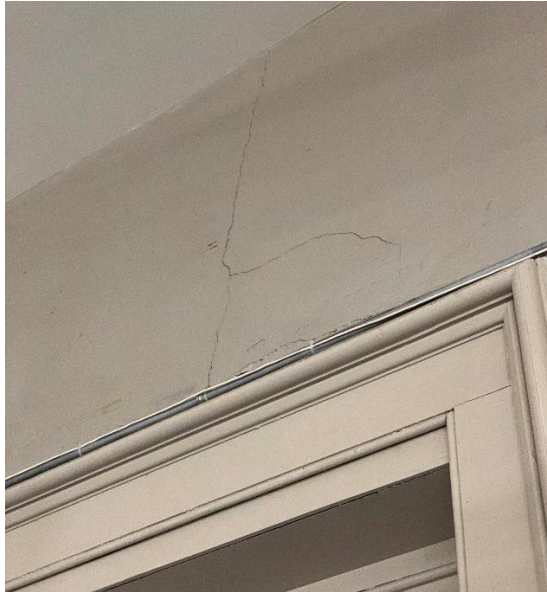
12. Walls are cracked, chipped, and need repair.

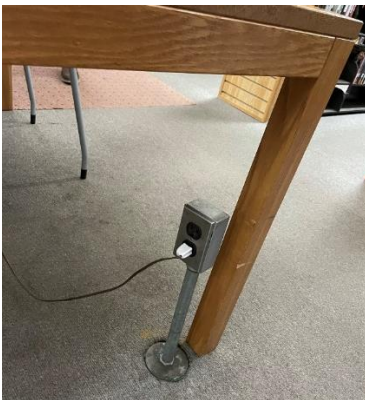
13. Power outlets in the main reading room are raised above the floor. The space does not have the flexibility to move the furniture since the power poles are a tripping hazard. Power outlets should be recessed into the floor for flexibility and safety.

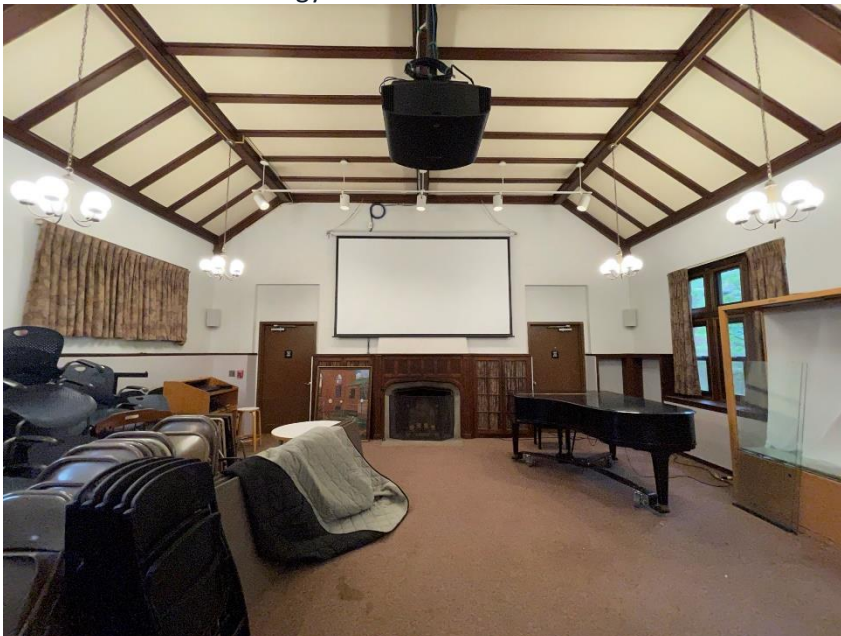
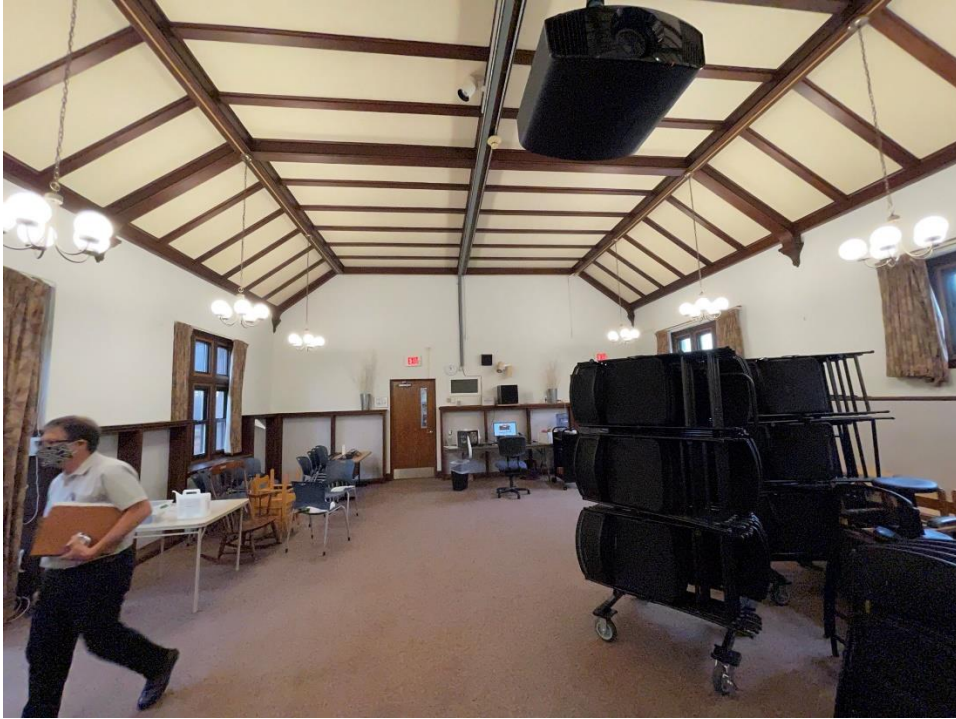
14. Hubbard hallway/ restrooms/ kitchen are not ADA compliant. Hallway too narrow and does not have proper maneuvering clearance to open the door. HVAC in the Hubbard room is ineffective. The entrance to the Hubbard room is obscure. It looks more "back of house corridor" than an important procession to a historic program room.

15. Two means of egress maybe required if the occupant load is above 49 and does not meet the code for automatic sprinklers. Hubbard room egress doors may be too close together. The doors down to children's area are confusing.
16. Hubbard Room technology is not state of the art.

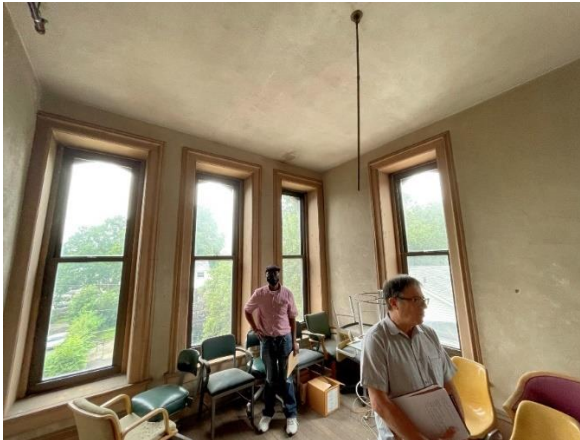
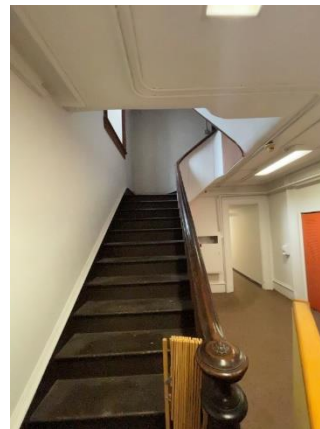
17. Hubbard Room accommodates only about 60 comfortably (in chairs). Chairs should be linked together to prevent them for being pushed and blocking egress in an emergency.
18. Church tower represents safety/ security risk. Stairway is hazardous- guardrails are too low and there is no handrail. The stair is blocked off by a movable partition. Area is not monitored.

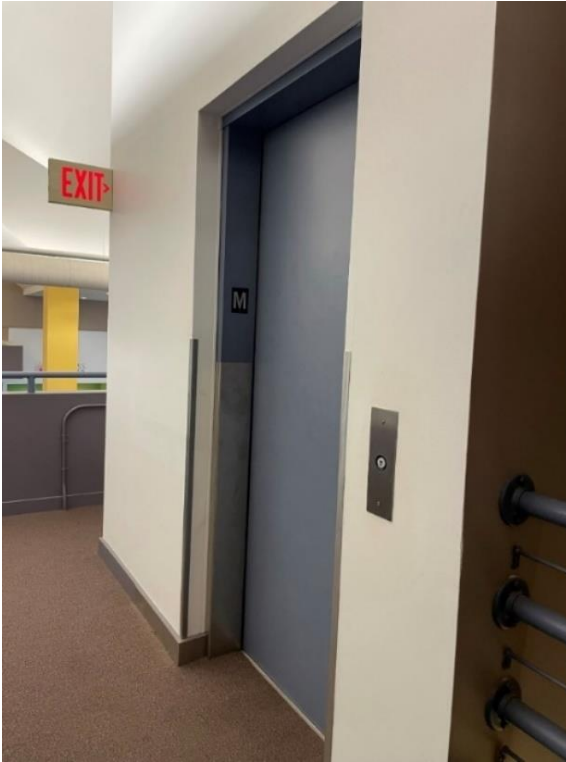
1. Elevator = 40 years old; most parts are obsolete. Has cost \$21,000 in repairs over the past 5 years alone including a current \$1,000 repair (October 1, 2021).

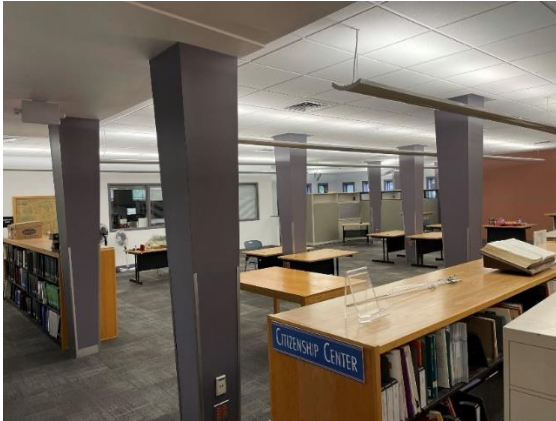
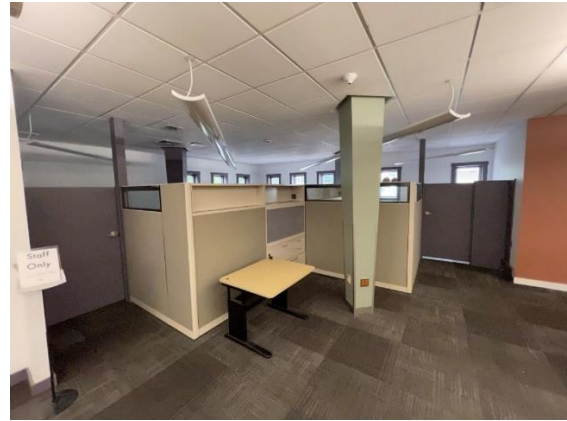
4. More staff offices tucked away/ cobbled together.

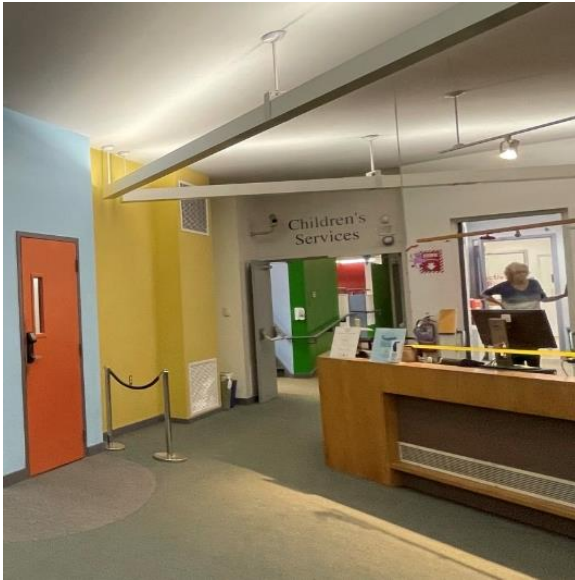
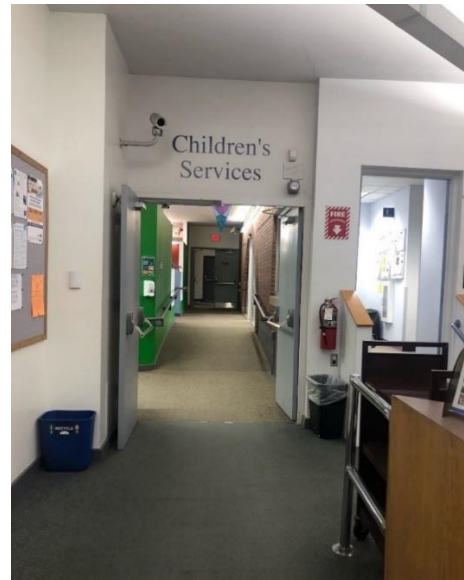
1. Entrance is not welcoming or obvious. Greeted by egress doors stairs and ramps.

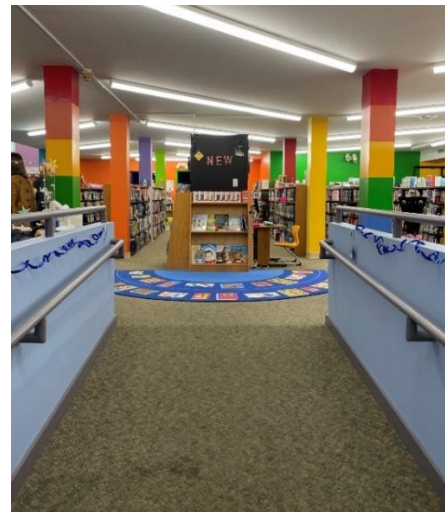
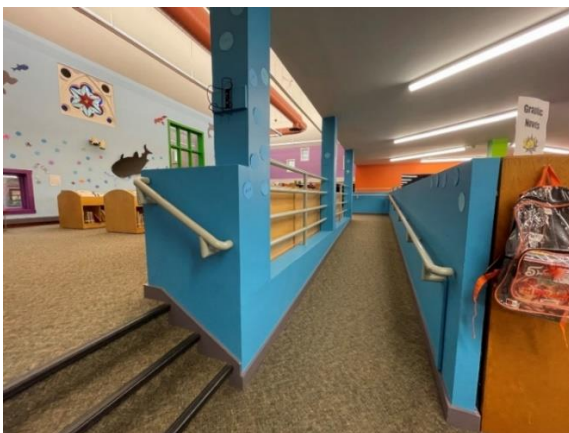
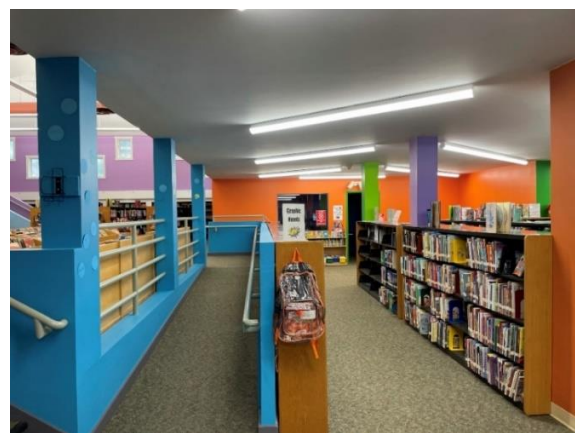
2. Ramps and stairs everywhere

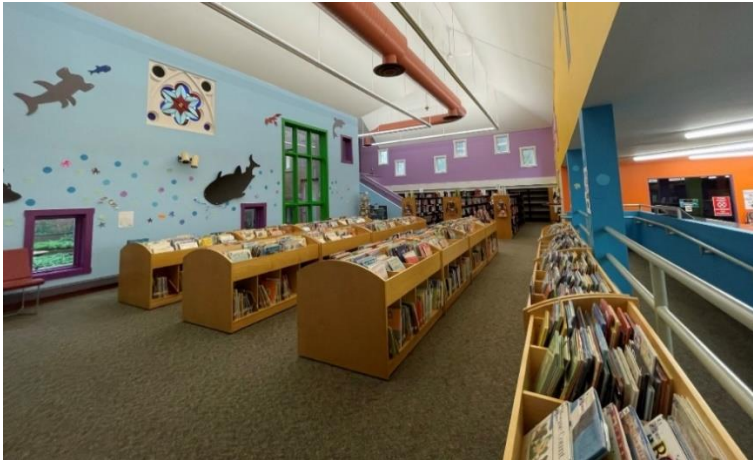
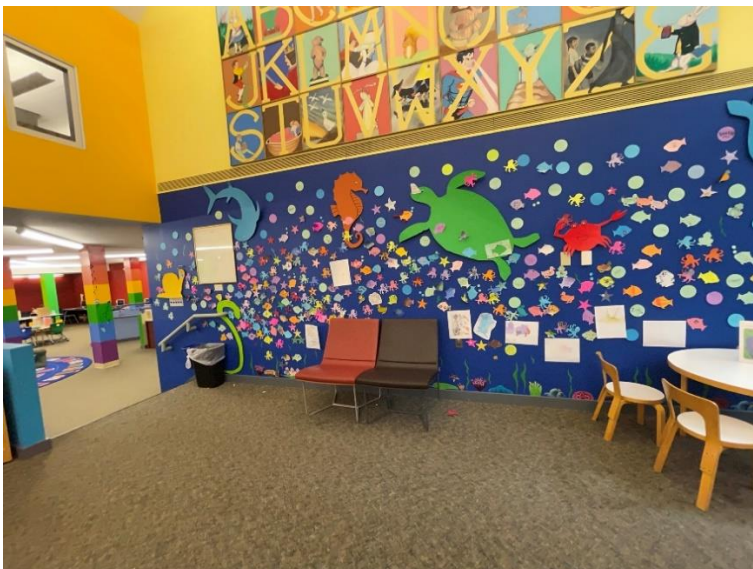
3. Hardly any seating/ play area. Not many seats for parents to sit with children.

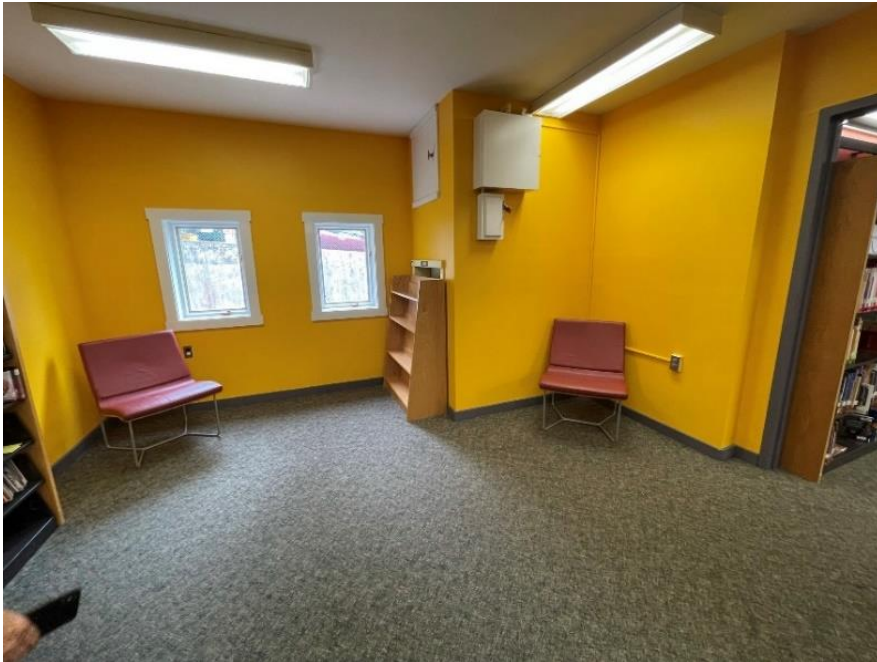
4. Extremely difficult to monitor because of level changes, nooks and crannies, separation of areas and an abundance of columns which makes creates poor visibility and sight lines.

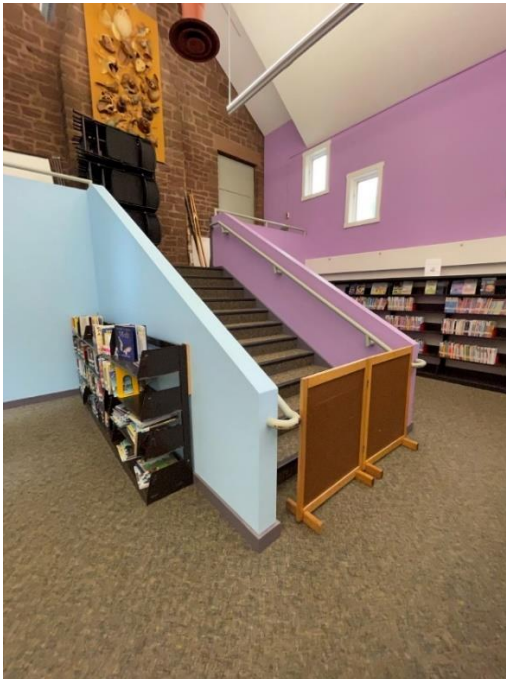
5. Exit signs are scarce and hard to see which is a life safety and egress issue.
6. No lactation area
7. There is a large open stair from the Children's area to the Hubbard Room which is blocked off and not used. The stair blocks sightlines around it, is navigationally confusing, a waste of space and a security issue for parents.

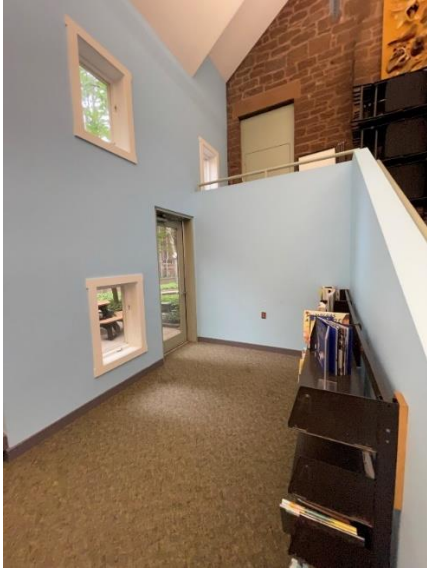
8. Courtyard Access- The only entrance to the courtyard with a ramp is in the Children's area. While it is nice to have outdoor space for families to use the access to the exterior is a security risk for children. In addition, it is not ideal to have adult patrons in need of a ramp to go to the children's area. The door to the courtyard is difficult to find. The zone between the courtyard door and the stairs to the Hubbard space is dead space and underutilized.

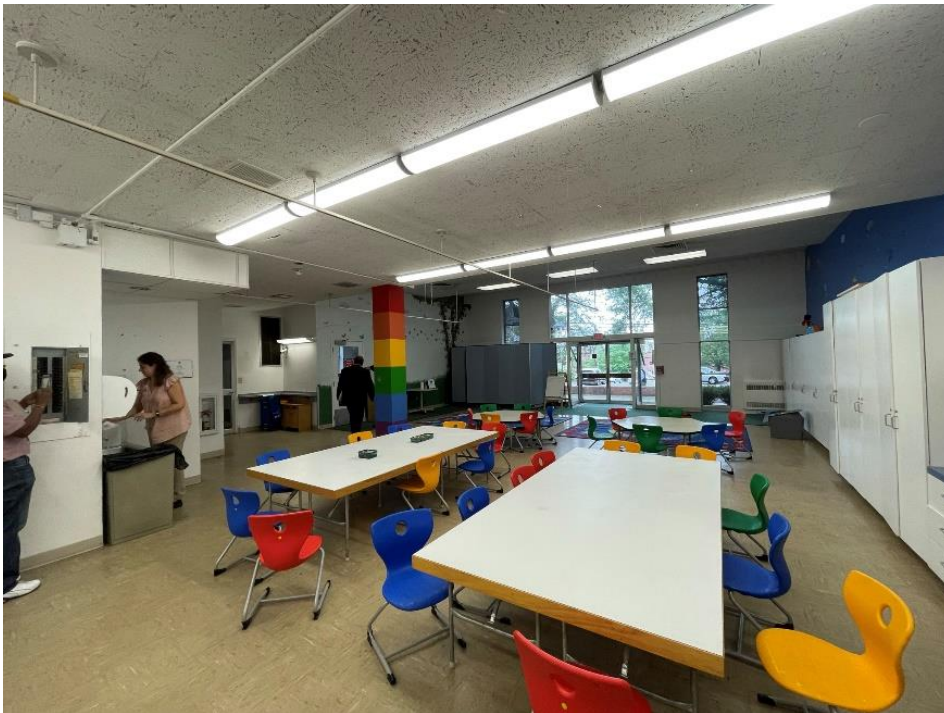
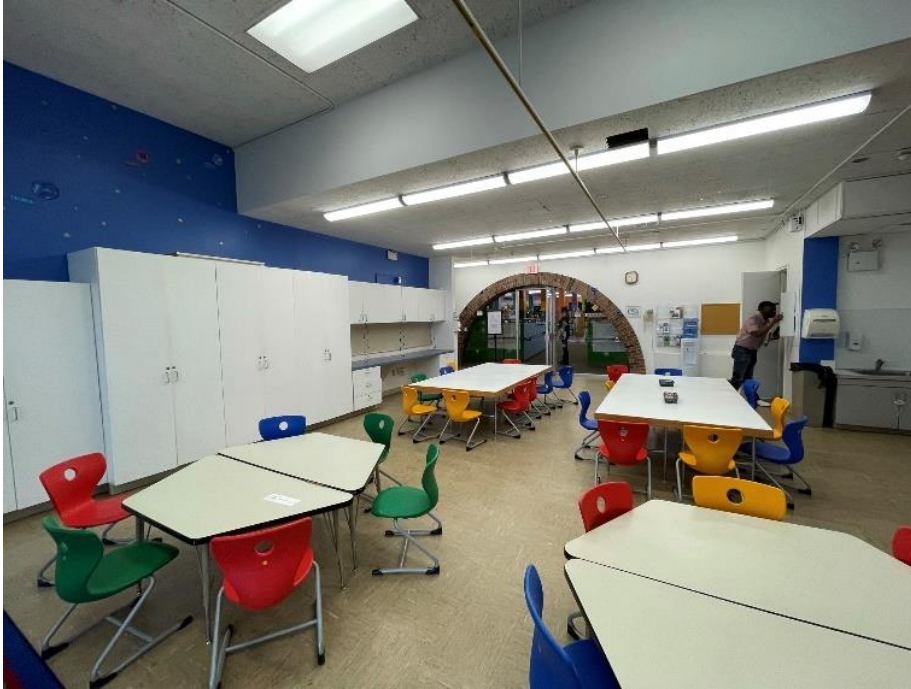
9. Disconnected from the Young Adult section on the other side of the library which makes it hard for parents to monitor multiple children of varying ages.
10. Having a large program room in the Children's area is an asset to the library, however, has a lot of wear and tear and needs significant updating including the bathroom, flooring, wall finishes, cabinetry, ceiling, lighting, glass entrance, etc.

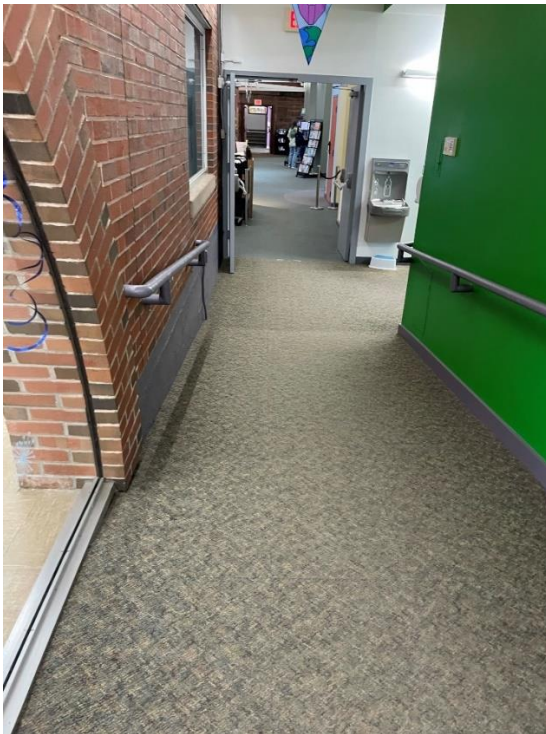
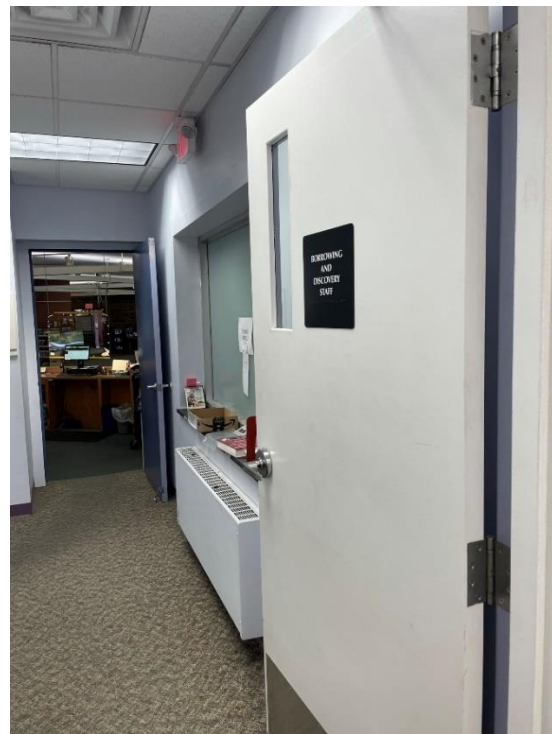
11. If the program room requires two means of egress, then the door from the library to the program room is swinging in the wrong direction. However, if the door swing switched directions to swing out, then the door swing would block the egress path on the ramp leading to the exit. The door from the program room into the Children's library has an exit sign and has an occupancy of over 49 people which would indicate two means of egress are required.

12. Program room is connected to the Borrowing and discovery staff room. Door was held open which is a security issue for children. (see right image above)

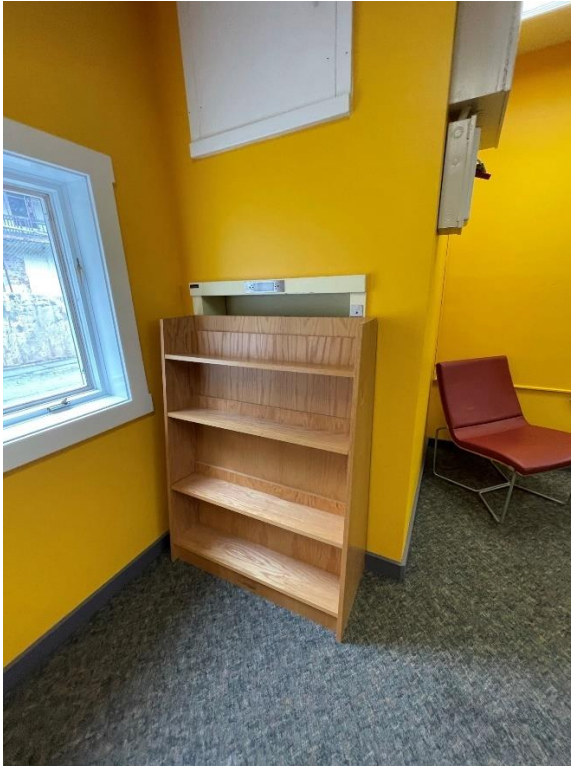
13. Empty bookshelf block the dumbwaiter which is awkward.

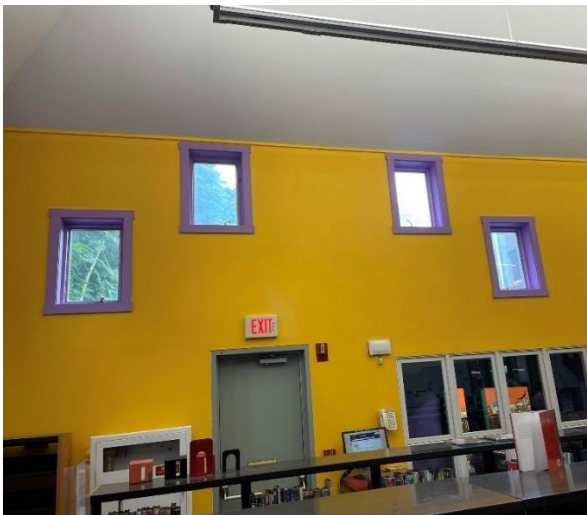
14. The windows in the children's area have manually operable cranks, however, they are too high to operate, which defeats the purpose. Some windows have views into interior offices with where unsightly furniture and boxes are facing the windows.

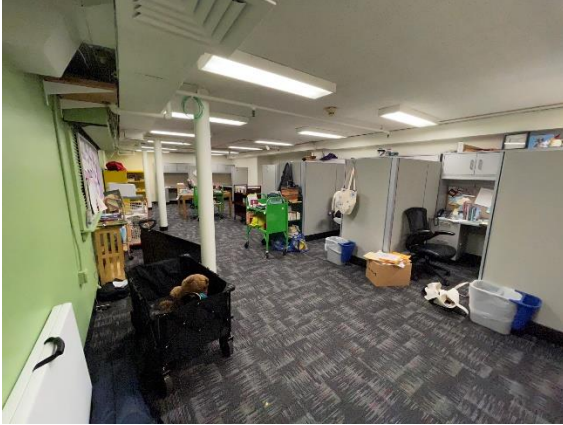
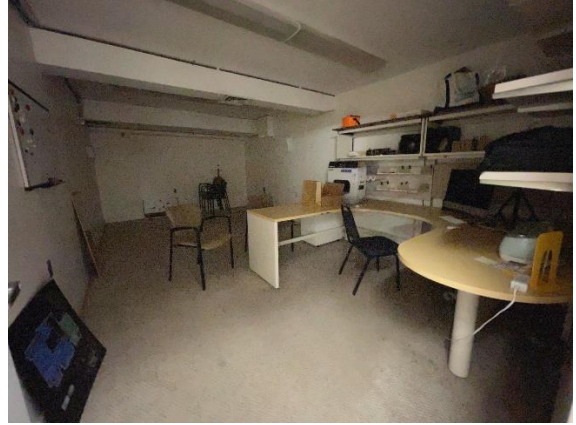
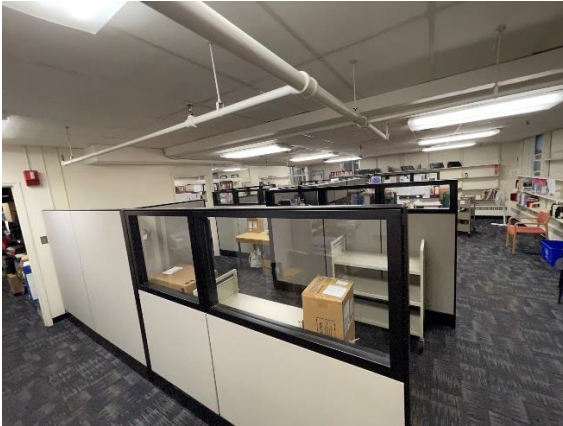
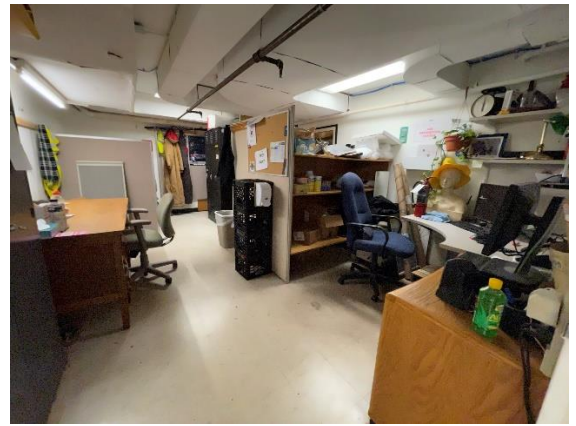
## **G. Basement**

1. No unified key card access, etc. Keypad or keyed doors.
2. Security issue- Door from lobby to the basement is locked by a keypad however the public can freely access the basement from other egress stairs on different floors without a key or code.
3. Staff offices squirreled away. No natural light. Disconnected from public.

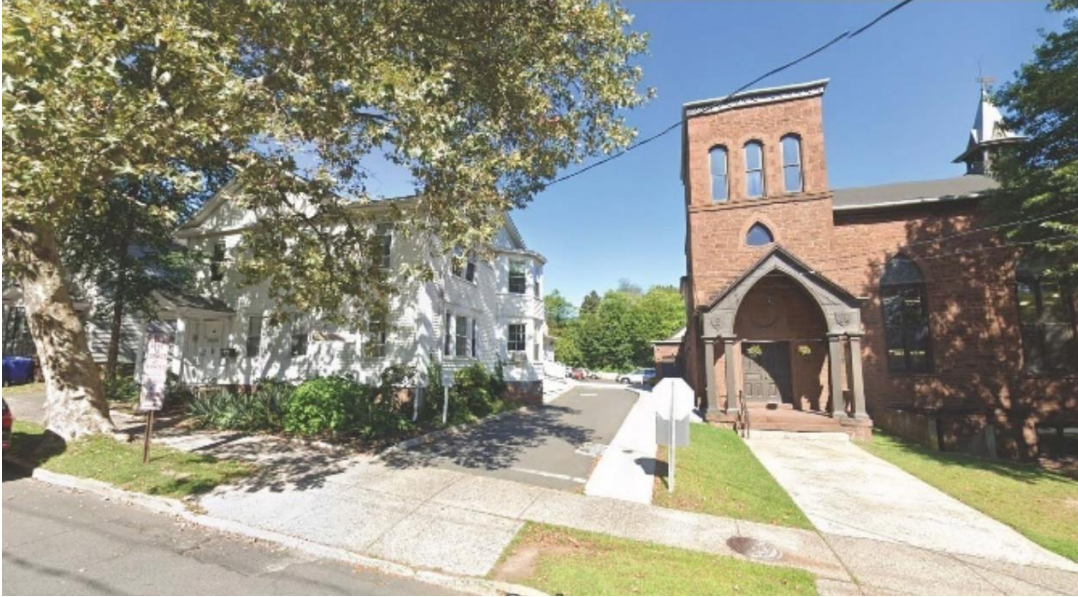
## H. Annex

1. Administrative offices are in a separate building. No covered walkway or enclosure to connect the two buildings. Not an ideal adjacency.

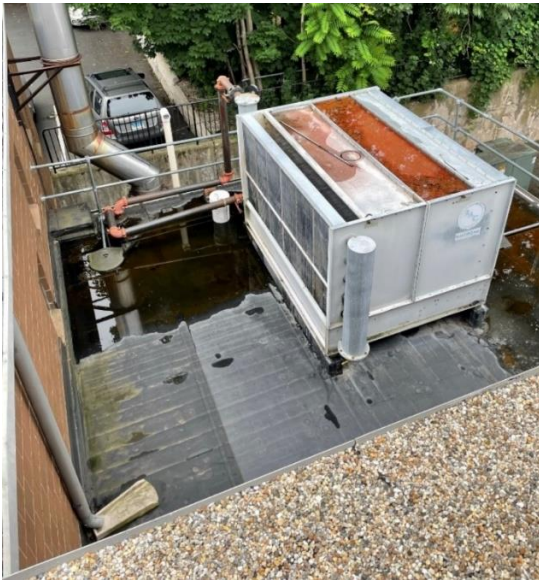
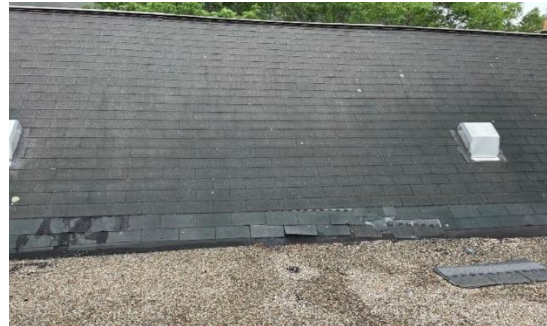
1. Roofing needs replacement

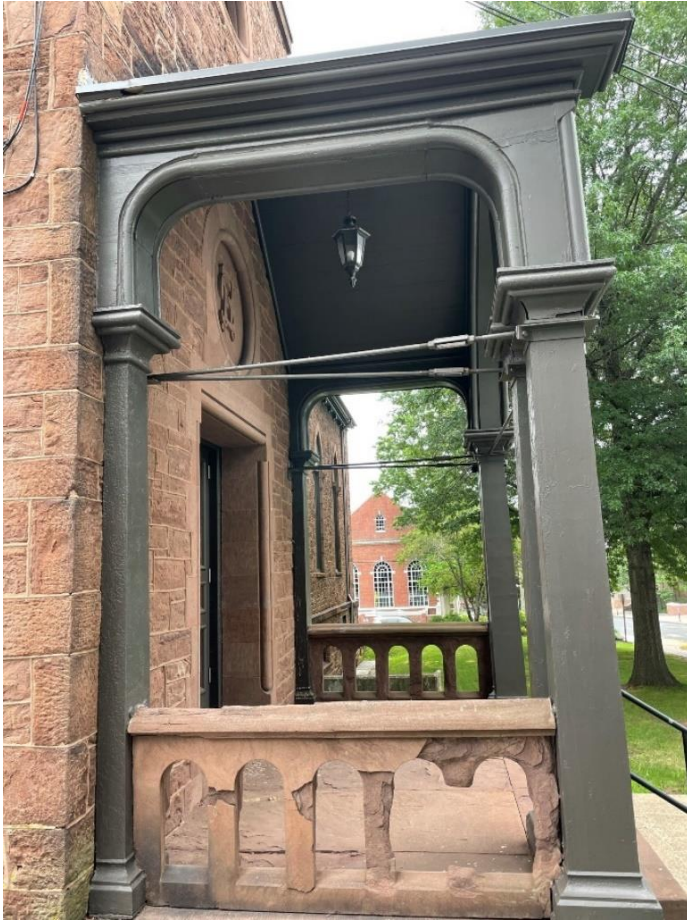
2. Crumbling Brownstone (see photo below)
3. Portico stabilizer bars were intended to be temporary (2013 study)

| Division 4A - Masonry | Qty | Unit | Unit Cost | AP Estimate | Notes |
|---|---|---|---|---|---|
| brownstone railings replacement at Court St entrance to Church Building | 2 | allow | 30,000 | \$60,000 | falling apart per AP Assement report; assuming rebuilt in kind (historic) |
| brownstone façade repointing allowance for repairs as needed per report | 1 | allow | 50,000 | \$50,000 | at several lower courses around building; see report for details |

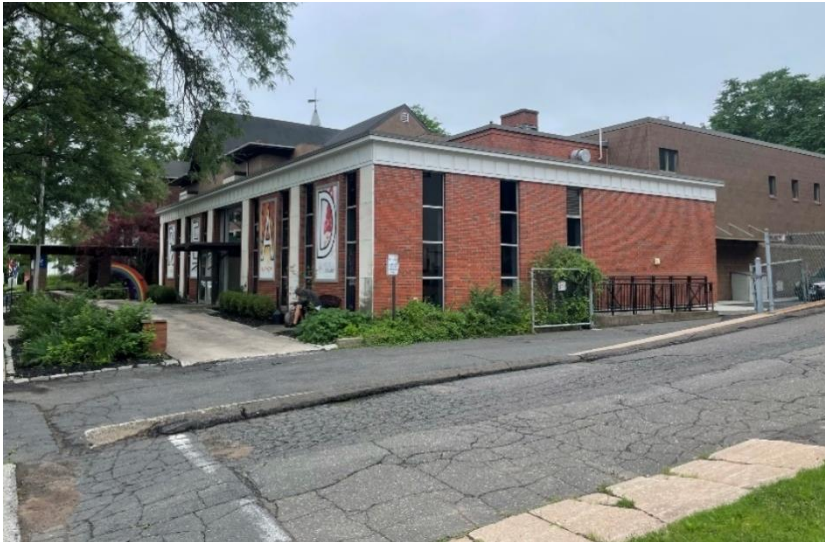
4. Driveway/ lots- need repaving

| Division 2B - Sitework | Qty | Unit | Unit Cost | AP Estimate | Notes |
|---|---|---|---|---|---|
| pavement - asphalt pavement replacement at North Driveway | 1 | ls | 15,000 | \$15,000 | repulverize and install new driveway cover |

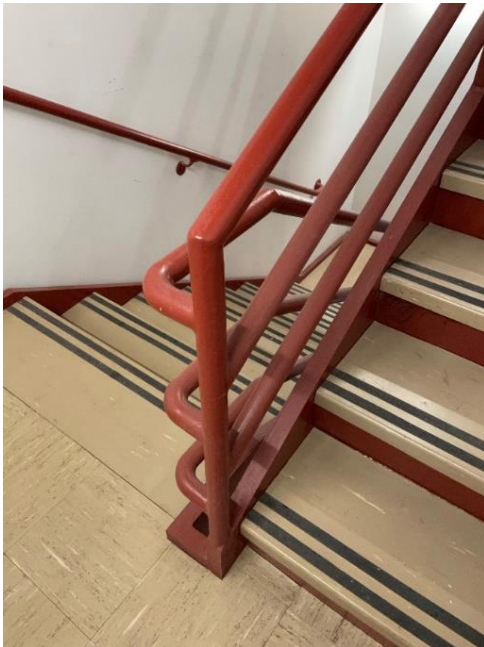
4. Handrails in egress stair are not continuous.

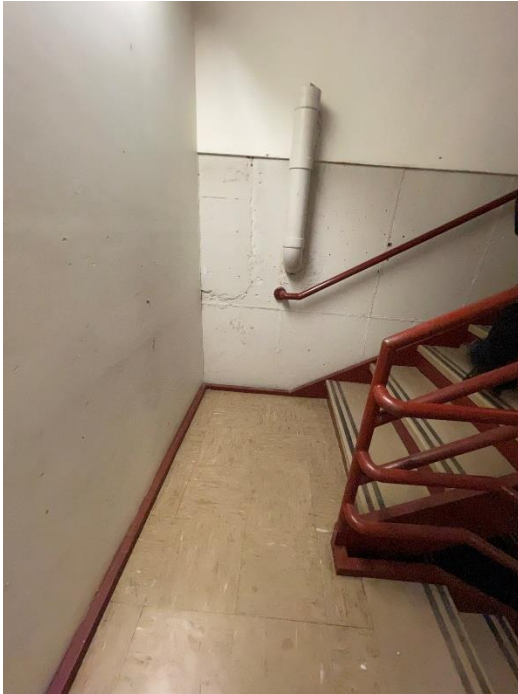
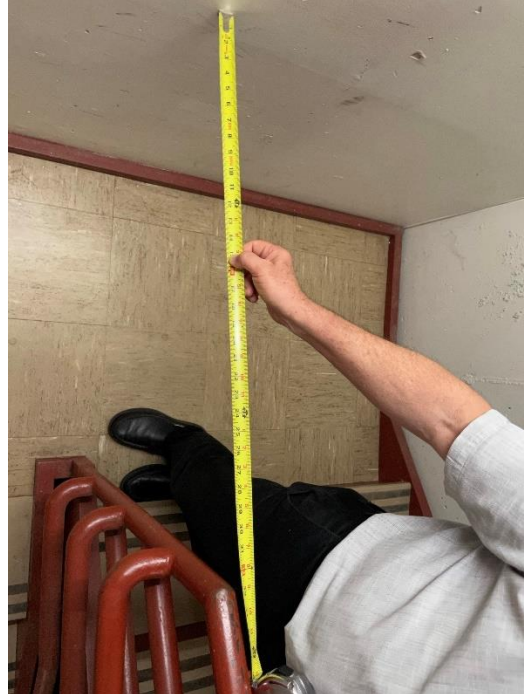
5. In the egress stair where an egress discharge is provided there should be an interruption gate to prevent users from continuing down the stairs and passing the exit.
6. Egress stair widths are too narrow at certain locations.

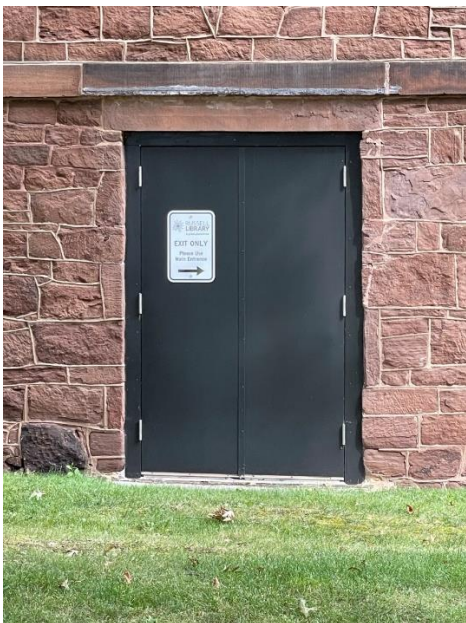
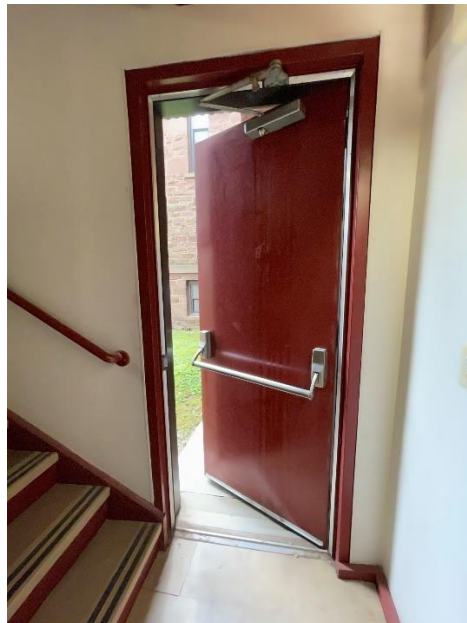
7. Many of the egress stairs do not exit onto a paved pathway to a public way which is a code issue.
